2015 Safe Routes to School Walk Audit Findings Report

EMERSON - WILLIAMS
SCHOOL

*Emerson-Williams Elementary School
Wethersfield, CT*

Submitted By:
VN Engineers, Inc.
116 Washington Avenue
North Haven, CT 06473
Phone (203) 234-7862

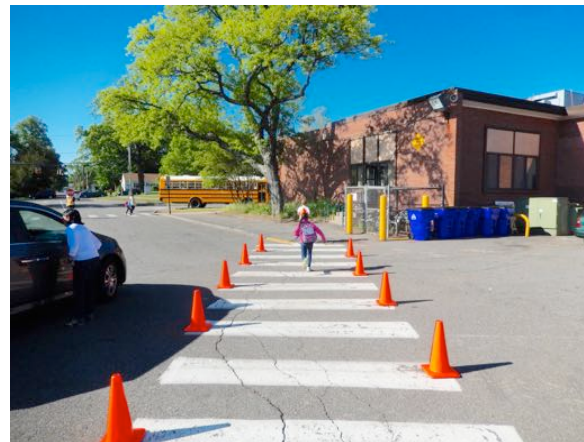
Figure 2: Drop-off Process on School Grounds

In general, the drop-off process functions orderly. The only significant concern was the driveway lane configuration, as the cars exit the school grounds. The main entrance consists of three lanes, one for *busses only* entering the school campus. The other two lanes are for *exiting* cars and busses. After the students exit the vehicles, parents have to maneuver to the correct lane to either turn left and thru, or turn right at the intersection of Wells Road. This weaving slows the exiting vehicles and causes some confusion and distraction as they proceed through the crosswalk **Figure 4**. The timing of the traffic signal seems appropriate for the traffic volumes, as no long queues or delays were observed.

The audit team also observed that the school officials have placed cones along the crosswalk that connects the student drop off and pick-up section with the main entrance sidewalk. The cones serve to further protect the crossing students from the vehicular traffic. (**Figure 2**).

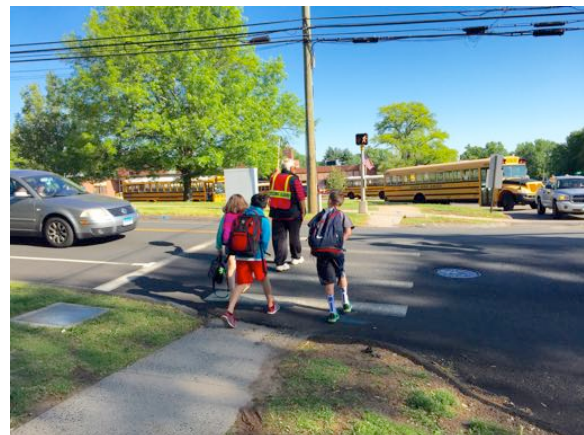
Figure 3: Police Trained School Crossing Guard

The Town of Wethersfield has assigned a trained crossing guard at the intersection of Wells Road and the main entrance to the School. The crossing guard was observed doing an excellent job of guiding students across the crosswalk, with the proper personal protective equipment and a hand held stop sign (**Figure 3**).

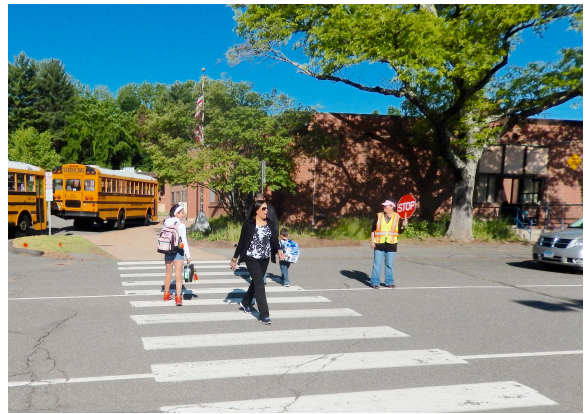
Figure 4: School Crossing Guard

In addition to the crossing guard at the intersection, the school has a trained crossing guard at the crosswalk leading from the main parking lot to the sidewalk near the main entrance. The crossing guard was well-trained and also had the correct personal protective equipment and handheld stop sign, **Figure 4**.

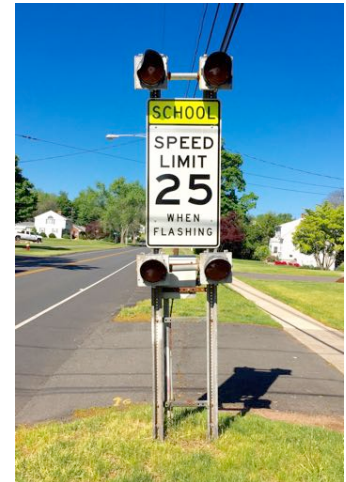
Figure 8: 25 mph Speed Limit Sign

The speed limit on these residential streets is **25 mph**. During our audit we did not notice any cars violating this posted speed limit. However, on Wells Street, directly in front of the school, the posted speed limit is **40 mph**. The Town has established a **25 mph school zone** and has installed two flashing school zone signs. One is located 250 feet to the east of the school, and the other is 900 feet to the west. The signs are in good condition and the flashing lights are activated during arrival and dismissal times (**Figure 8**). During arrival and dismissal traffic speeds were observed to be slower than 40 mph, without police enforcement. Principal Neela Thakur has petitioned the police to intermittently enforce the posted speed limit on Wells Street, which has lessened the speed violations. All the other signs along this walking route are in good condition.

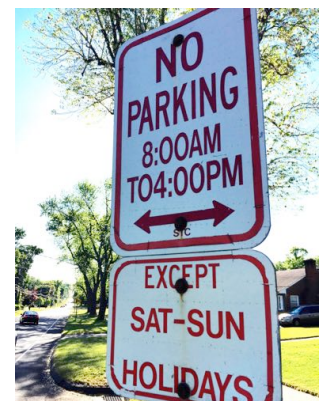
Figure 9: NO PARKING Signs on Mapleside Drive

Near the intersection of Wells Road and Mapleside Drive, the Town has installed **NO PARKING** signs south of the school on Mapleside Drive. This posted signage is to prevent parents from meeting their children on Mapleside, in front of the school, rather than entering the school property (**Figure 9**). During the arrival period, no vehicles stationed themselves at this location; however the audit team reported that at pickup there were at least ten cars parked in the street waiting for students. This is not an optimal condition, forcing students to enter the stationed vehicles on a two-way street in an undesignated parking zone. This could be mitigated by the parent education programs and police enforcement.

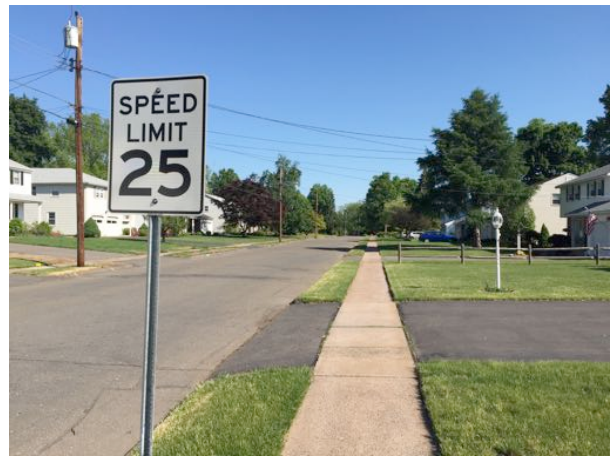
Figure 12: Speed Limit Sign on Mapleside Drive

The speed limit on these residential streets is 25 mph. During our audit the SRTS Team did not witness any vehicles speeding. All the signs along this walking route are in good condition (**Figure 12**).

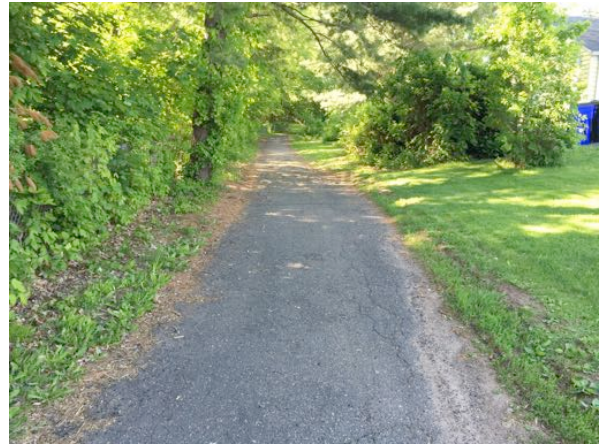
Figure 14: Wood Trail North of School

Walking Route 3 commences at the school cafeteria and heads north along a well-maintained wooded path to Western Boulevard. The SRTS Champion identified this as one of the primary walking and biking routes. There was some concern about the physical isolation and path condition, however the audit team found the path to be amenable to walking and biking. During the winter months, snow accumulation may pose a significant problem if the Town chooses not to plow this area (**Figure 14**). Once the students exit the wooded path, they emerge onto Western Boulevard (**Figure 15**). This route allows access to Crest Street, Sunrise Terrace, Valley View Drive, Wells Farm Road and other surrounding streets. It is a well-kept residential area. The path is less than 0.5 miles long depending on the origin and destination of the trip (**Figure 13**).

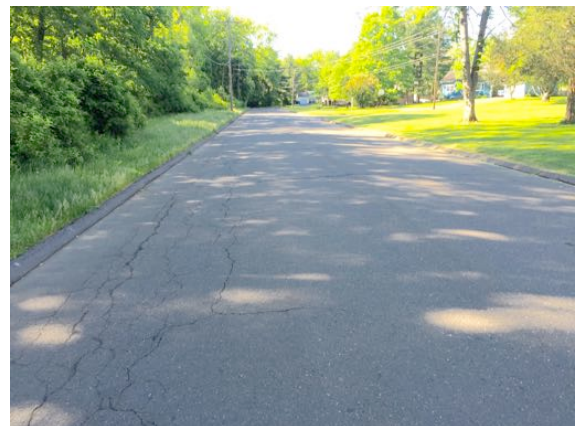
Figure 15: Western Boulevard (Looking South)

The speed limit on these residential streets is **25 mph**. During our audit, no speeding cars were observed. All the signs along this walking route are well-maintained.

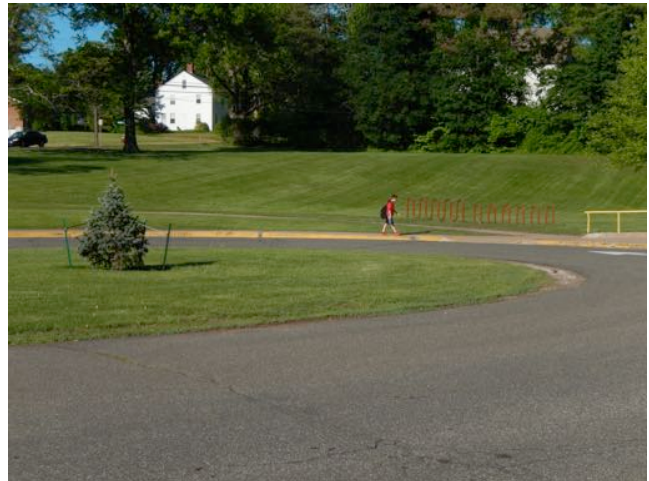
Figure 16: Sidewalk wrapping around the bus loop

- The school has a sidewalk that wraps around the pickup and drop-off area and the bus loop, encouraging students to circumvent the parking lot and the bus route, see **Figure 16**.

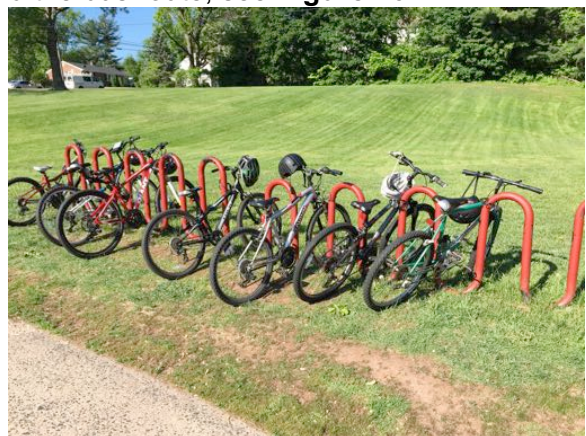
Figure 17: Two Large Bike Racks Available for Students

- The school has two adequately sized bike racks, in fair condition, see **Figure 17**.
- There are sidewalks available for travel on both sides of Wells Road, with ample buffers between the edge of the road and the sidewalk. This separation of roadway and sidewalk is categorized as ideal for pedestrian travel.

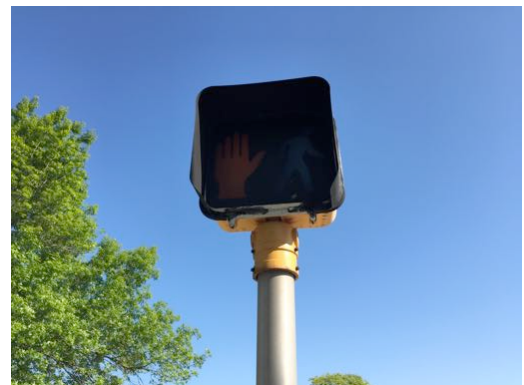
Figure 20: Pedestrian Signal Located on North Side of Wells Road

- The pedestrian signal located on the north side of Wells Road is not functioning properly (**Figure 20**). The DONT WALK light bulb has not functioned for over a year. All of the pedestrian signal heads should be upgraded to the latest Manual on Uniform Traffic Devices (MUTCD) Count Down pedestrian head Standard. Since the traffic signal equipment at this location (Int. 159-226) is Town owned and maintained, the Town is responsible for replacing any malfunctioning equipment.
