2015 Safe Routes to School Walk Audit Findings Report

Charles Wright
Elementary School

*Charles Wright Elementary School
Wethersfield, CT*

VN Engineers, Inc.

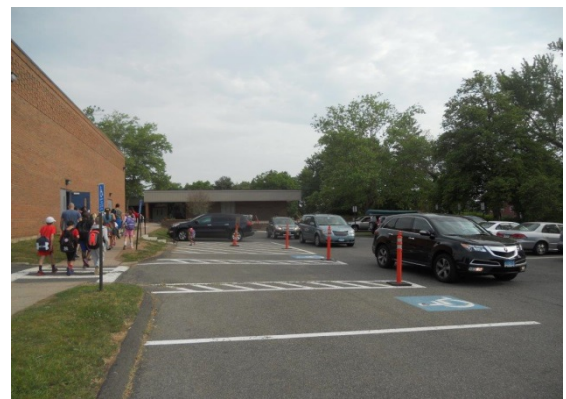
Figure 2: Drop-Off Process at Parents/Guardians Parking Lot

Parents/Guardians drop off students in the second (larger) parking lot. Cones are placed in front of six (6) parking spaces to create a drop-off area for students. Typically vehicles wait in a queue until the school doors open at 8:10 a.m. Vehicles then make a counter-clockwise loop through the parking lot to drop students off at the designated drop-off area. The school principal is on hand to meet and assist students as they exit their vehicles.

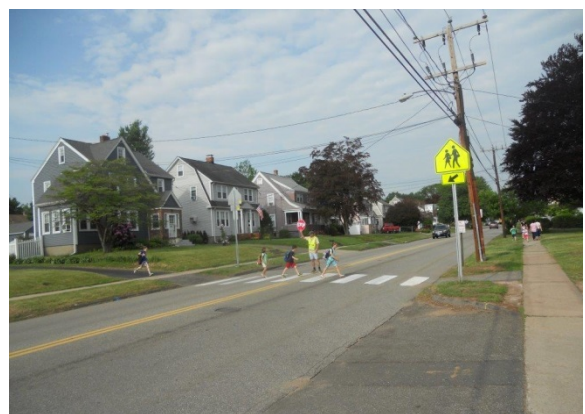
Figure 3: Crossing Guard helping Students Cross at Nott Street

The Town of Wethersfield has assigned three crossing guards dedicated to students walking to and from Charles Wright Elementary School and other schools nearby (**Figure 3**).

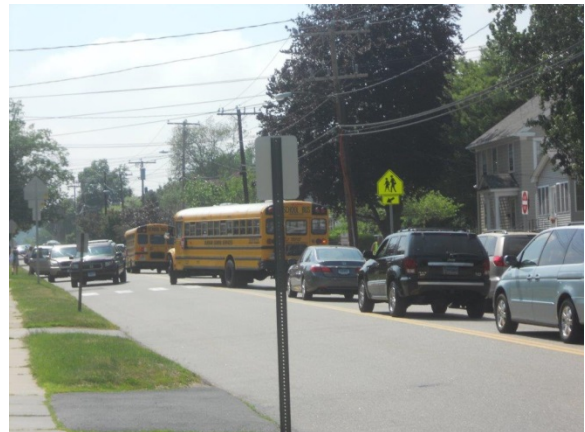
Figure 4: Illegally Parked Cars in Front of School Causing Congestion on Nott Street

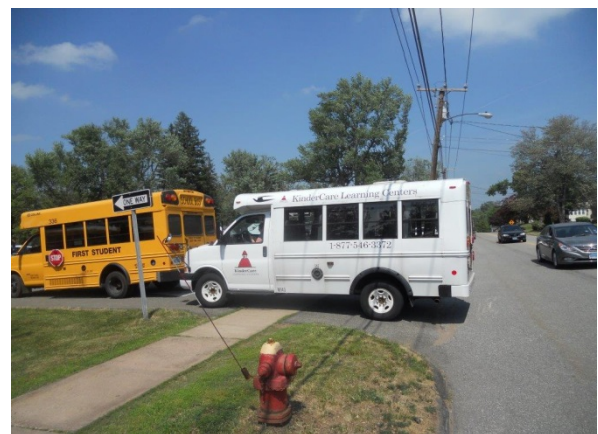
Figure 5: School Buses Blocking Sidewalk and Part of Roadway

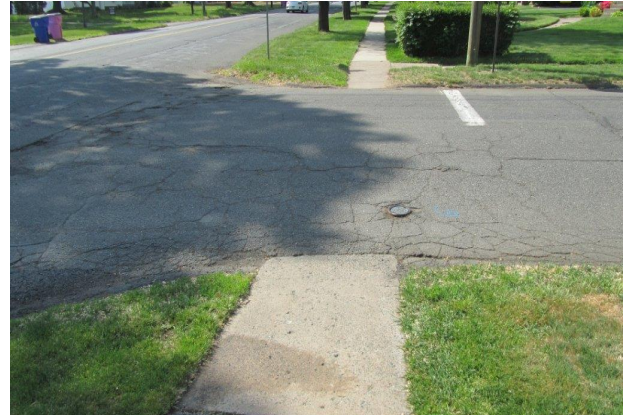
In general, the pavement quality in Pedestrian Zone # 1 is in good condition, except for a portion of the intersection of Robbins Drive with Wolcott Hill Road as shown in **Figure 8**. The pavement at the intersection of Wolcott Hill Road and Cottwell Drive/Wethersfield High School Drive is in fair condition with a few cracks in the pavement.

Figure 8: Poor Pavement Condition at Wolcott Hill Road and Robbins Drive

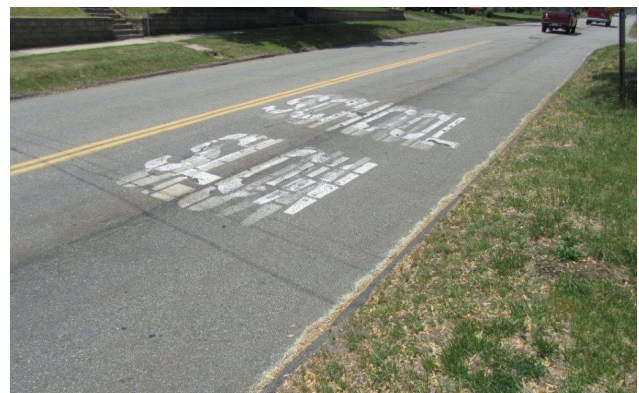
Figure 9: Poorly Painted SCHOOL SLOW Pavement Markings

- All "SCHOOL SLOW" pavement markings and crosswalks should be permanently removed (not blacked out) and restriped or replaced with SCHOOL ZONE pavement markings (MUTCD Section 7C.03) and the appropriate corresponding school zone signage to alert motorists that they have entered a school zone per Connecticut Department's School Zone Guidelines shown as an attachment.

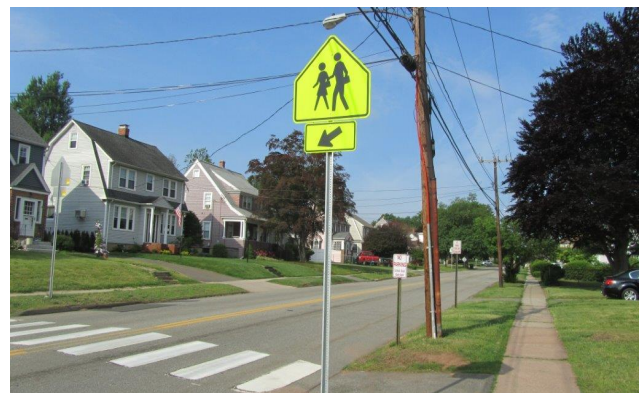
Figure 10: School Crossing Sign on Nott Street

There are SCHOOL CROSSING signs with downward arrow at the crosswalk in front of the school on Nott Street (**Figure 10**). There are also advanced SCHOOL CROSSING signs with 25 mph signs on both approaches on Nott Street Other locations with SCHOOL CROSSING signs in this zone are Wolcott Hill Road at Cottwell Drive/Wethersfield High

School Drive northbound/southbound approaches; Wolcott Hill Road at Church Street northbound/southbound approaches; and Nott Street westbound approach to Wolcott Hill Road. All SCHOOL CROSSING signs within Pedestrian Zone #1 appear to be recently installed.

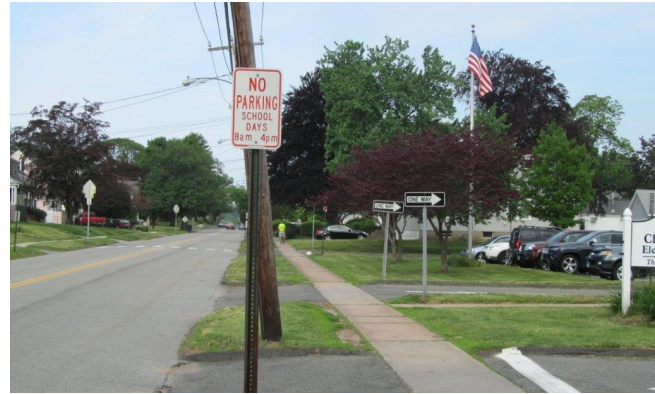
Figure 11: NO PARKING SCHOOL DAYS Signs in Front of School

There are also a number of “NO PARKING SCHOOL DAYS 8 am – 4pm” signs along Nott Street in front of the school (**Figure 11**). Ideally, these postings prevent cars from parking in the vicinity of the school, which should positively impact the visibility and travel space for both walkers and bikers. However, as noted earlier, these signs were not obeyed during the walk audit.

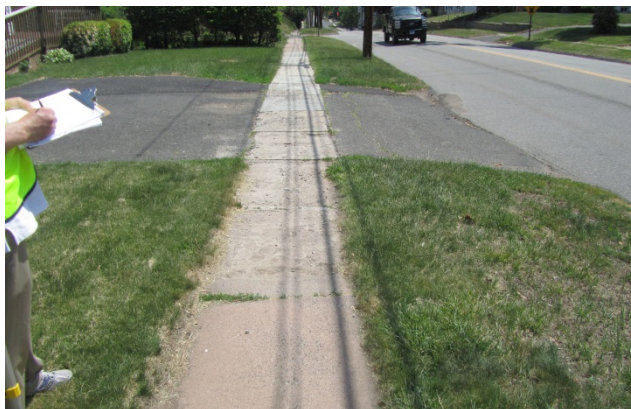
All streets surrounding Charles Wright Elementary School in Pedestrian Zone #1 have sidewalks on both sides of the road. Almost all sidewalks also have grass strips that were typically 4’ wide or greater which serve as a buffer between the sidewalk and the roadway. Generally, the sidewalk pavement at all locations along potential walking and biking routes were in fair to good condition. However, there were a few areas where the sidewalk area is in poor condition. An example is the sidewalk along Nott Street, to the east of the school entrance and just before the intersection with Wright Road as shown in **Figure** .

Figure 13: Sidewalk along Nott Street in Poor Condition

- Reconstruct deteriorated sidewalk along Nott Street, install detectable warning strips where there are none and repair any damaged sidewalks within pedestrian zones.

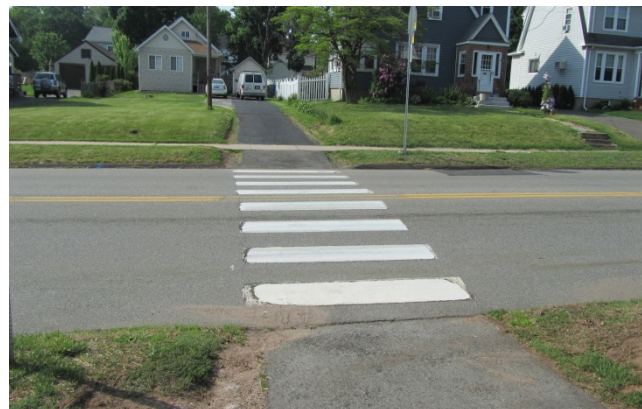
With the exception of a few locations, most curb ramps in this area were not American with Disabilities Act (ADA) compliant with no detectable warning strips. There are a few locations where the curb ramp slopes are too steep or the crosswalk is aligned with a private driveway ramp (**Figure**).

Figure 12: Crosswalk Aligned with Private Driveway along Nott Street

- Regrade and repair the handicap ramps and install detectable warning strips mentioned in above-mentioned tables and/or relocate the crosswalks. Where possible, install perpendicular handicap ramps with detectable warning strips. Some locations are mentioned below:
 - a. Crosswalk on north leg of Wolcott Hill Road at Nott Street extends to a handicap ramp at the NW corner that is steep and not ADA compliant. This handicap ramp needs regrading, detectable warning strip, and/or angled to be ADA compliant.
 - b. Crosswalk across Nott Street in front of the School extends to a private driveway to the north side of the road. This needs to be shifted further east to direct pedestrians directly onto the sidewalk. Install yield lines and corresponding "Yield Here to Pedestrians" sign (R1-5) or a similar sign, at least 20 feet in advance of the crosswalk for both approaches.

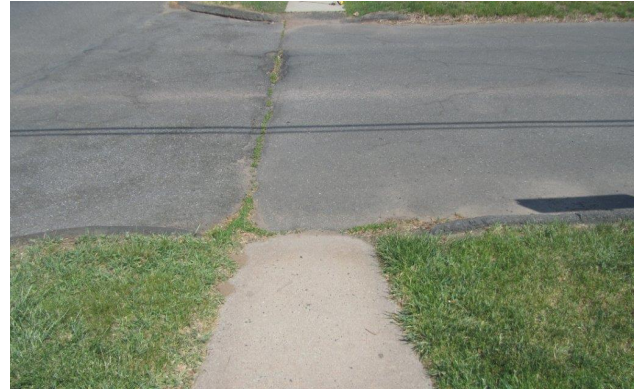
In general, the roadway pavement quality in Pedestrian Zone # 2 is in fairly good condition, except for a few locations along Wolcott Hill Road. There are areas of light rutting, and longitudinal/transverse cracking at the intersection of Wolcott Hill Road and Cumberland Avenue as shown in **Figure 15**.

Figure 15: Longitudinal and Transverse Cracking at Wolcott Hill Road and Cumberland Avenue

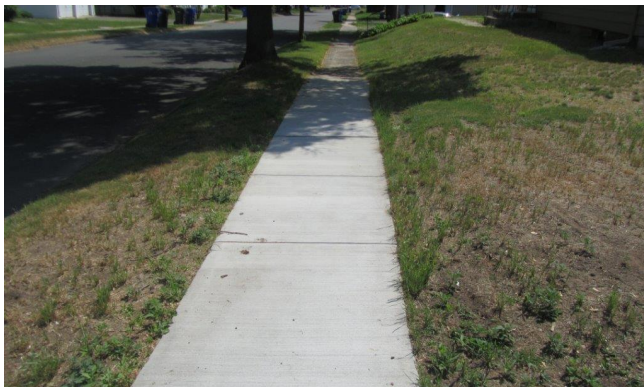
Figure 16: New Sidewalk at Wolcott Hill Road and Knoll Street/Lorraine Road

Most streets surrounding Charles Wright Elementary School in Pedestrian Zone #2 have sidewalks on both sides of the road. Almost all sidewalks also have grass strips that on average were 6' wide or greater which serve as a buffer between traffic and pedestrians using the sidewalk. Generally, the sidewalk pavement at all locations along potential walking and biking routes were in fair to good condition. There are a few locations where new sidewalk has been installed such as the intersection of Wolcott Hill Road and Knoll Street/Lorraine Road (**Figure 16**). All curb ramps in this area were not American with Disabilities Act (ADA) compliant with no detectable warning strips. The curb ramps at the Wolcott Hill Road and Cumberland Avenue are in poor condition (**Figure 17**). A summary of locations with crosswalk and curb ramp issues is shown in **Table 3**.

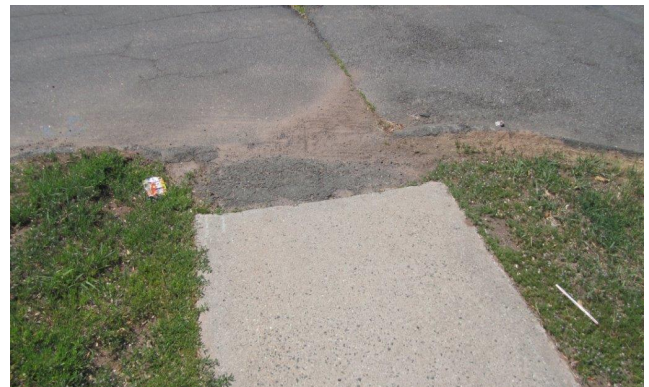
Figure 17: Poor Condition of Curb Ramps at Wolcott Hill Road at Cumberland Avenue

Location	Approach(es)	Issue	Quantity
Nott Street/Wolcott Hill Road	S	Steep slope Handicap ramp (NW)	1
Wolcott Hill Road/Cumberland Avenue	E,W	Handicap ramps in poor condition	1
TOTALS			2

- d. Install detectable warning strips and repair handicap ramps at Wolcott Hill Road and Cumberland Avenue to be ADA compliant.
- Due to the fact that students use the paths from Cumberland Avenue and Oxford Street, it is recommended that handicap ramps with detectable warning strips, crosswalks, sidewalks and appropriate signs are provided for crossing the respective streets to access the path leading to the school. A concept is shown in **Figure 30**. If possible, the school can also consider requesting a crossing guard be stationed at the proposed Oxford Street crossing location.

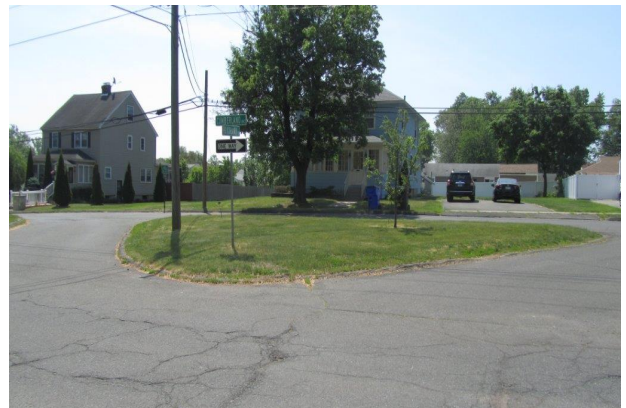
In general, the roadway pavement quality in Pedestrian Zone # 3 is in fairly good condition, except for a few locations along Cumberland Avenue. There are areas of light rutting, and longitudinal/transverse cracking at the intersection Cumberland Avenue and Buckland Road as shown in **Figure 19**.

Figure 19: Longitudinal and Transverse Cracking at Cumberland Avenue and Buckland Road

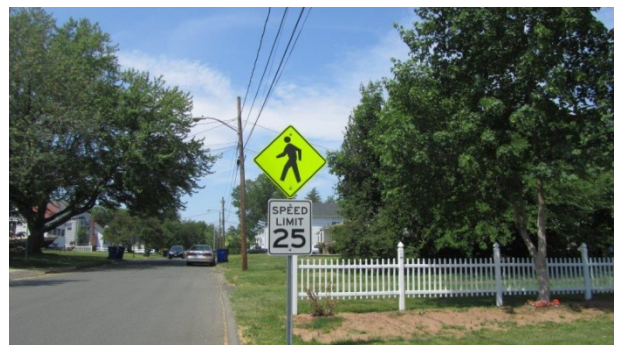
Figure 20: Pedestrian Crossing Sign on Oxford Street

The posted speed limit for most streets within Pedestrian Zone # 3 is 25 mph, except Nott Street that has a speed limit of 30 mph. While the speed limit is posted as 25 mph on Cumberland Avenue and Oxford Street, observed speeds were higher. This observation is particularly concerning because students cross these roads to access the walk/bike paths to the school. There are bicycle route signs on Cumberland Avenue and Nott Street. There are pedestrian crossing signs along Oxford Street in the vicinity of the bike path (**Figure 20**). However there is no existing crosswalk or curb ramp.

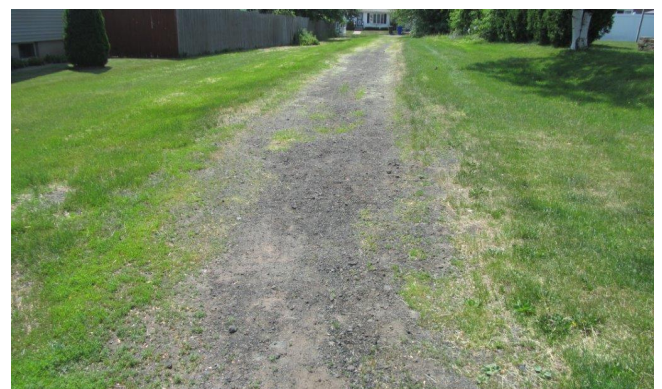
The condition of the gravel path that runs from Cumberland Avenue to Oxford Street is poor and not ADA compliant. It consists of loose gravel material and does not provide a firm and stable trail surface, especially in wet weather. The path surface has grass and weeds growing on the trail surface as shown in **Figure 21**.

Figure 21: Poor Surface Condition on Gravel Path

- Resurface gravel path with a suitable, durable and permeable material that offers improved drainage and provides a firm and stable path surface.
 - Fill areas of light rutting and longitudinal/transverse cracking on walk/bike path on the school grounds. Fully repair areas that are severely deteriorated, such as areas next to drainage catch basins, tree roots, etc. Regrade path in the vicinity of the parking lot to reduce the slope and make it ADA compliant.

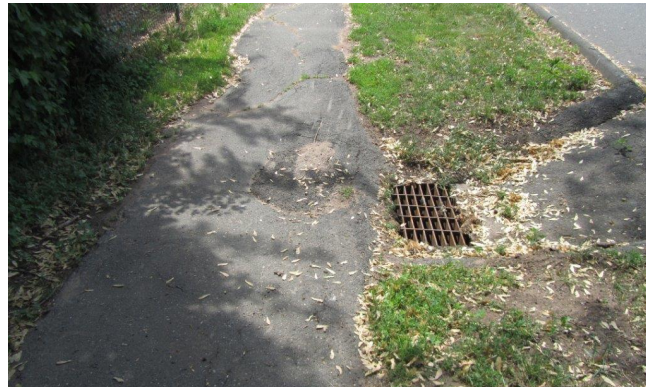
The walk/bike path on the school grounds is generally in fair condition. There are areas of light rutting, and longitudinal/transverse cracking along the path. There are also sections of the path, particularly

next to drainage catch basins that show significant signs of deterioration as shown in **Figure 22**. This results in an uneven surface which is not suitable for ADA accessibility. It is noted that this path is also used as an emergency evacuation route.

Figure 22: Deterioration of Pavement Condition along School Walk/Bike Path

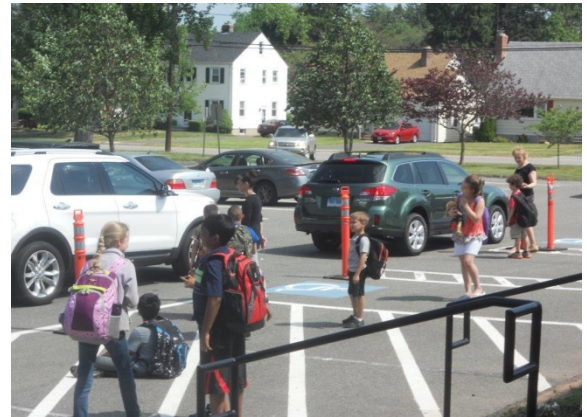
Figure 23: Teachers assisting students during dismissal process.

- School buses line up at the smaller parking lot and let students out for arrival all at once after the school doors open.
- The pickup of students by parents is well coordinated with three (3) staff members on hand to assist. One of the staff members uses a bull horn to keep order (**Figure 23**).

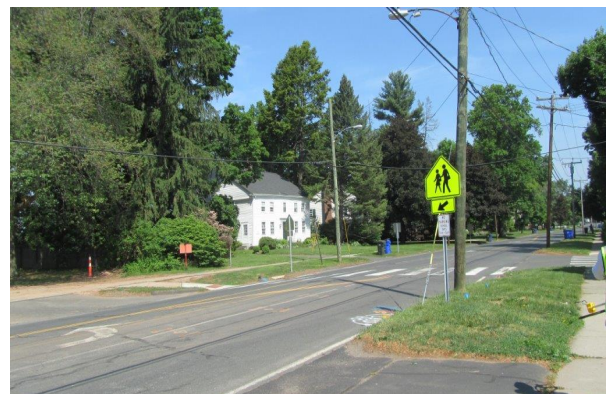
- New Signs were installed with old signs, lowering the older signs and crowding the sign posts as seen in **Figure 24**. Some signs within the area were installed too low, where pedestrians can potentially hit the sign.
- The school traffic circulation pattern causes issues. Several parents dropped off students without waiting for the vehicle queue to dissipate and drove by the queued vehicles resulting in a safety issue. Also, during morning

Figure 24: Newly Installed Signs Crowding Older Signs

- It is recommended that over time all signage around the school be updated to meet MUTCD current specifications, particularly with regards to size, reflectivity, mounting height (MUTCD Figure 2A-2) and the fluorescent yellow-green color. The areas surrounding the school were recently updated with the MUTCD S1-1 School Crossing assembly signs with the arrow sub-plate, but are missing several advanced warning signs as mentioned previously. An example of the MUTCD S1-1 school sign is shown in **Figure 28**. According to the MUTCD, the school advance crossing assembly, with the "AHEAD" sub-plate, should be located 100 feet from the crosswalk. None of the school advance crossing assemblies has the "AHEAD" sub-plates. All of the Stop Ahead signs (W3-1) are outdated at the intersections of Wolcott Hill Road/Nott Street and Wolcott Hill Road/Church Street and lack proper reflectivity.

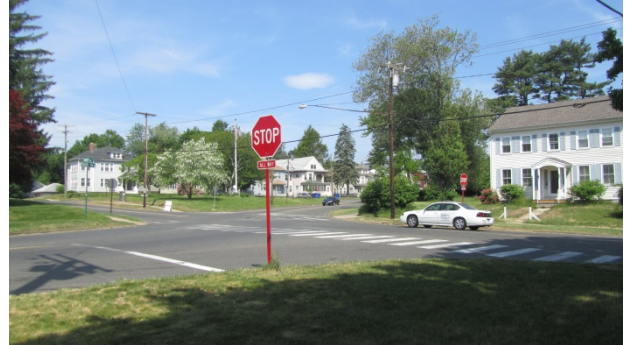
Figure 25: Long Crosswalk at Wolcott Hill Road and Nott Street

crosswalks as seen in **Figure 25**. The alignment of this intersection does not provide adequate sight distance from all approaches, resulting in a safety issue for pedestrians and motorists.

- c. Realign Wolcott Hill Road northbound approach with the southbound approach. This realignment will result in shorter crosswalk lengths across Nott Street and also provide pedestrian crosswalks at all four approaches. This concept as illustrated in **Figure 32** will improve safety and sightline issues at the intersection.

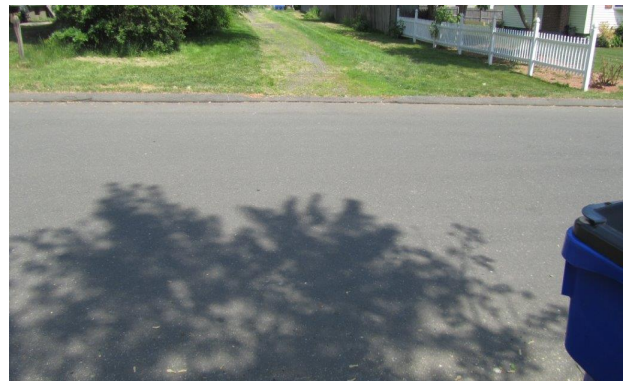
Figure 26: Lack of Crosswalk or Curb Ramps for Crossing Oxford Street from Gravel Path

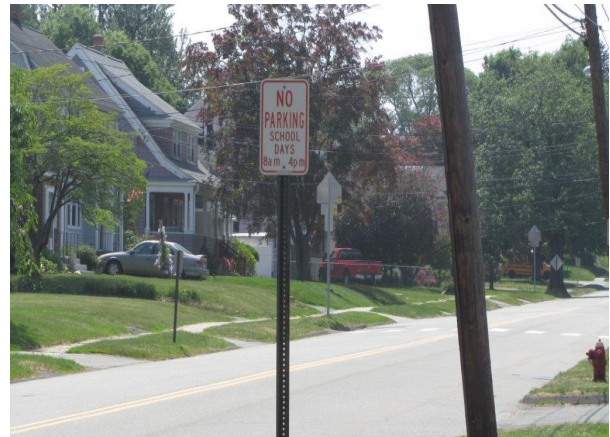
Figure 27: No Parking School Days Sign

- The SRTS Program provides free pedestrian and bike education for students and parents. The SRTS committee could contact the SRTS team to arrange follow up training or check the CTDOT website after September 2016 for more information². These education programs would clarify for parents where to walk their children within the school drop-off areas.
- Attend a Driver and Passenger Educational program to clarify drop-off procedures to new parents at the beginning of the school year, taking into account the separate bus drop-off and parent drop-off lots. An educational program would also ensure that drop-off procedures operate without impacting adjacent roadways and sidewalks (**Figure 27**).

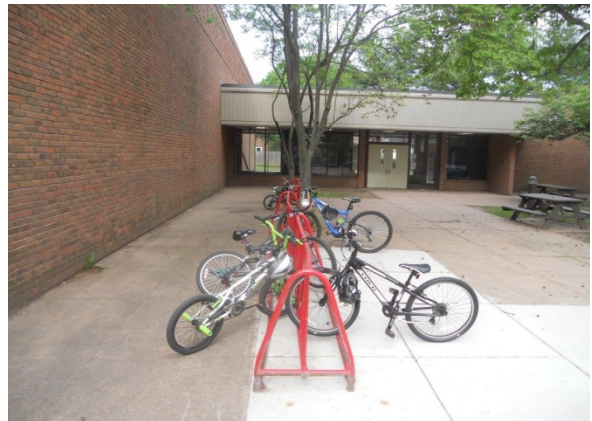
Figure 29: Bicycle Racks and Parking at School

- Walking Wednesdays, Walking / Biking contests, and mileage tracking could continue the encouragement of walking and biking to school throughout the year (**Figure 29**).
- Walking School Buses/Bicycle Trains consist of groups of students accompanied by adults that walk or bike a pre-planned route to school. Since students have one or two adults walking with them, this activity addresses parents' concerns about traffic and personal safety.
- Encourage faculty and staff directing traffic to wear safety vests.

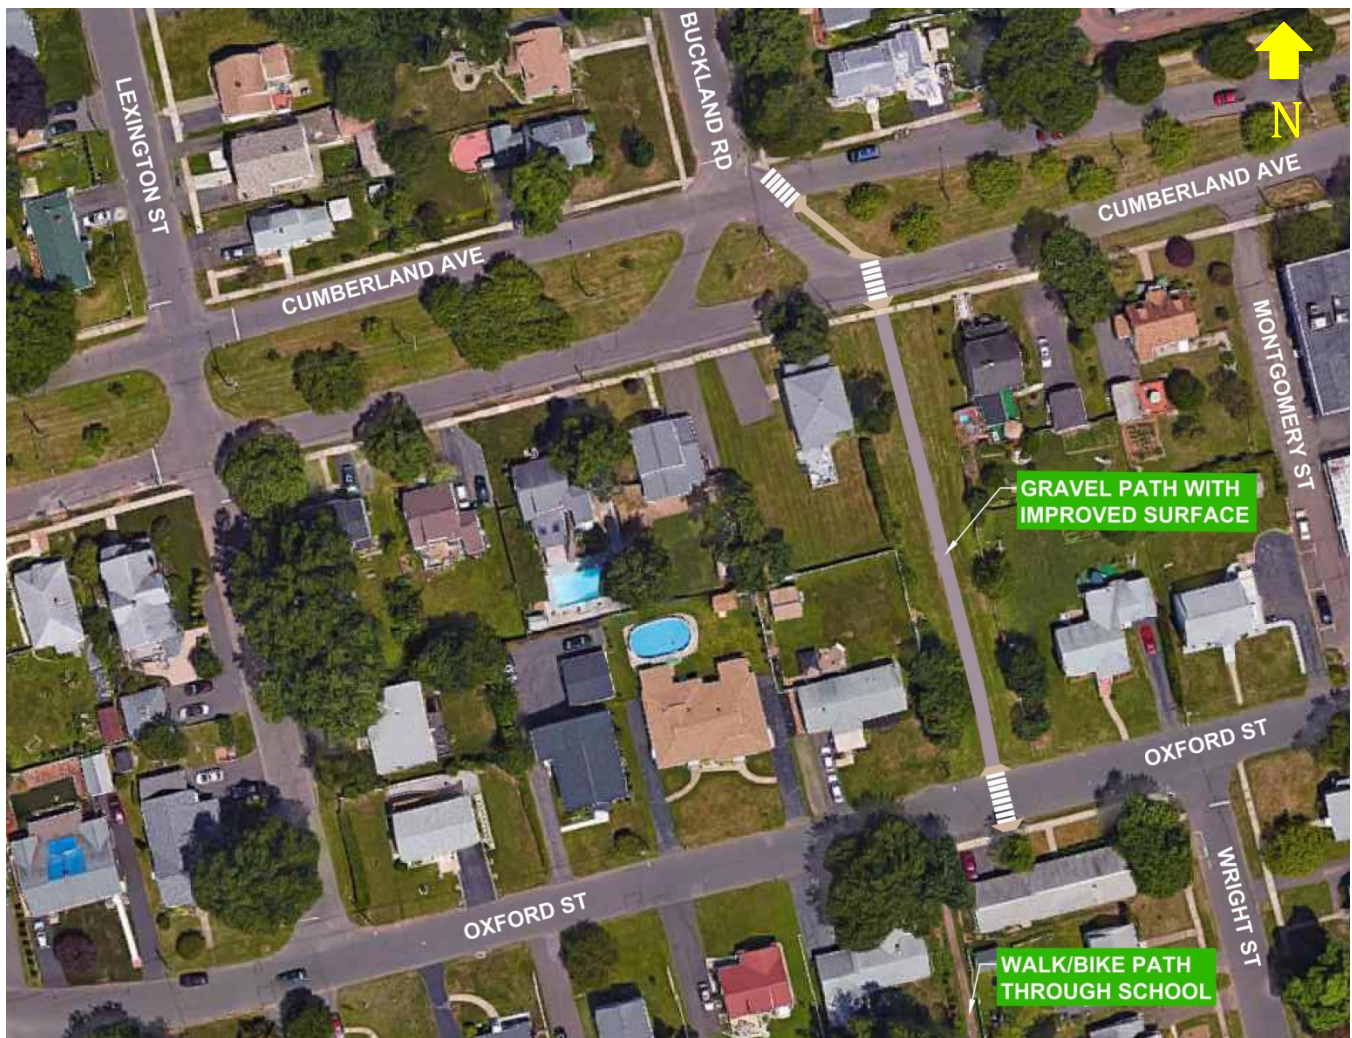
Figure 30: Concept Showing Proposed Crosswalks, Ramps and Sidewalks on Cumberland Avenue and Oxford Street

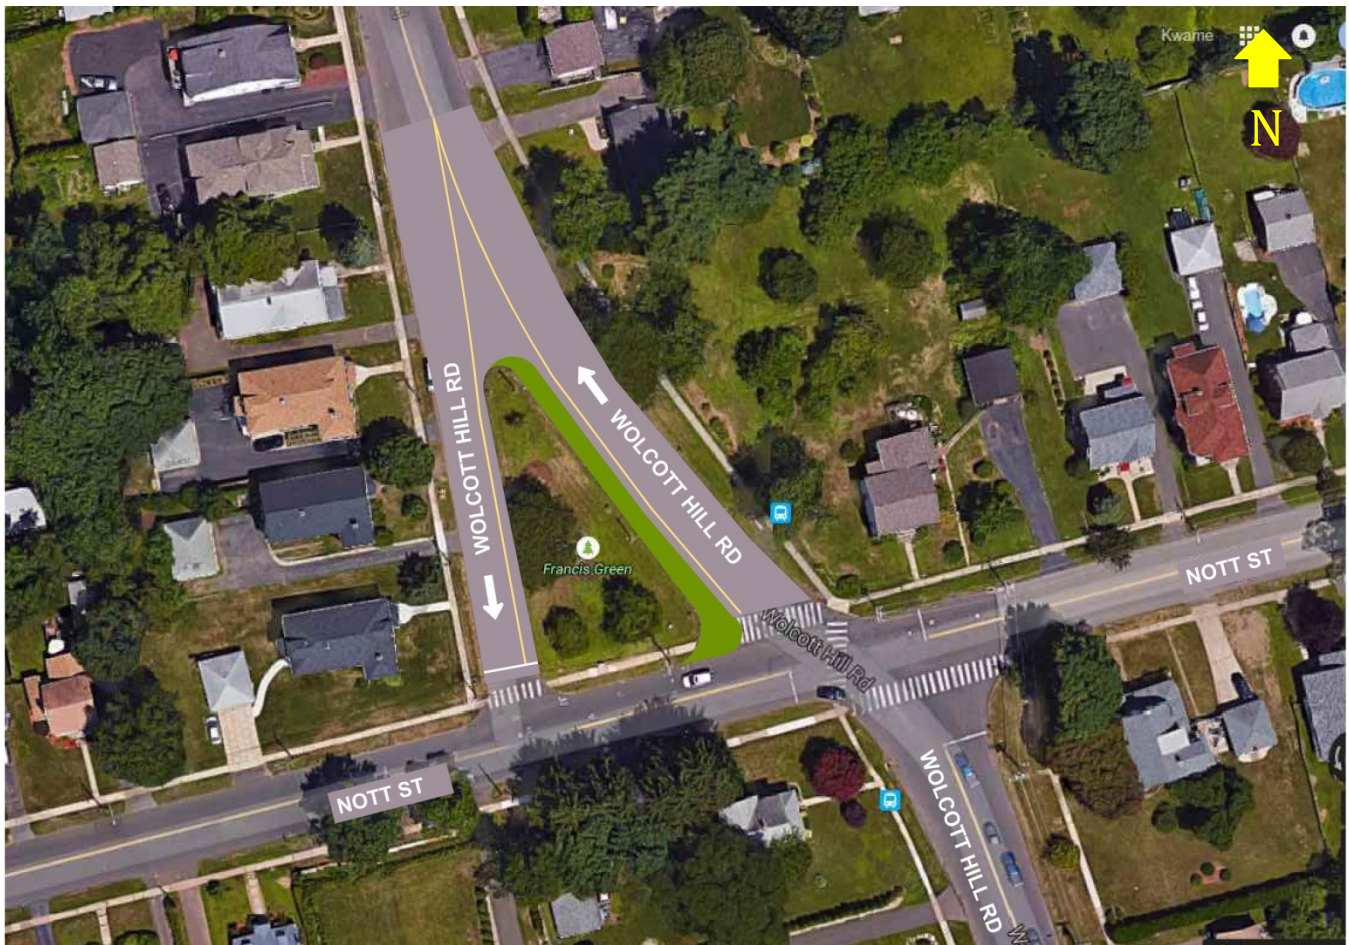
Figure 31: Concept Showing Proposed One-Way Split at Wolcott Hill Road and Nott Street

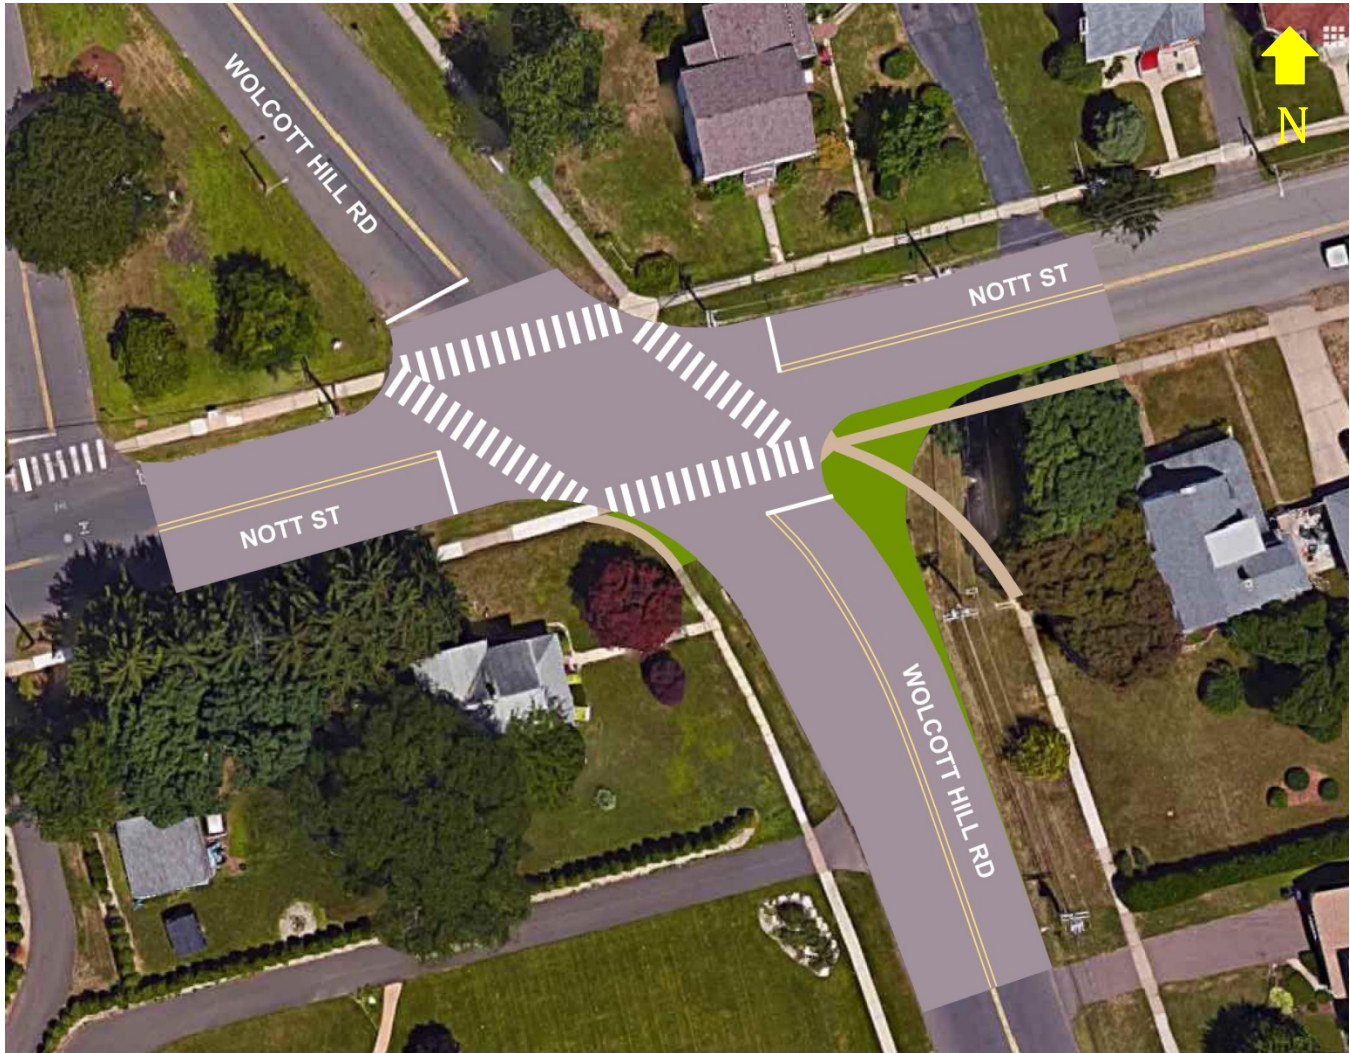
Figure 32: Concept Showing Proposed Realignment of Wolcott Hill Road and Nott Street Intersection
