2015 Safe Routes to School Walk Audit Findings Report

*Alfred Welles Hanmer Elementary School
Wethersfield, CT*

Submitted By:
VN Engineers, Inc.
116 Washington Avenue
North Haven, CT 06473
Phone (203) 234-7862

October, 2015

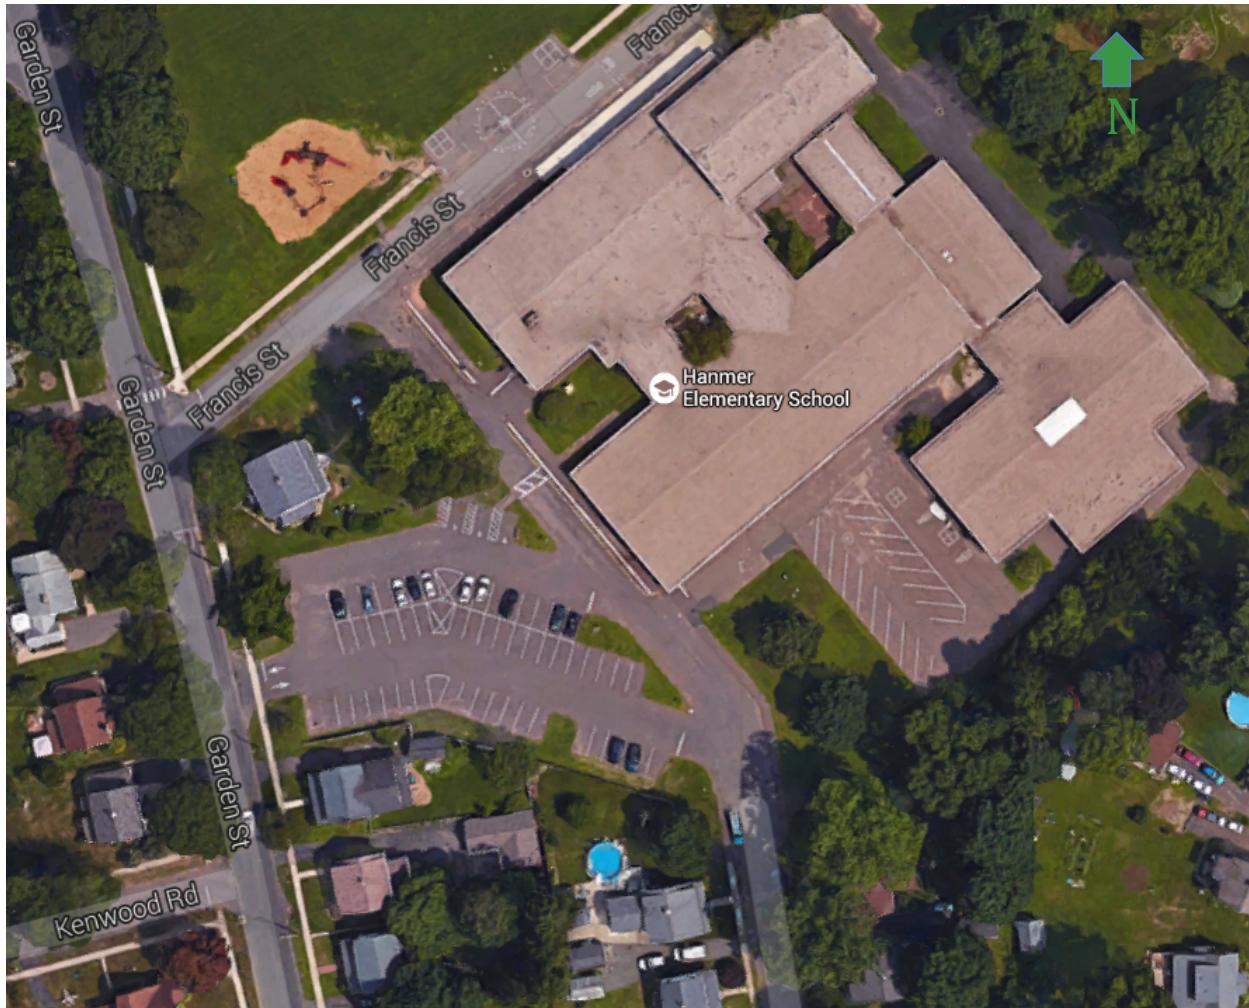
Figure 2: Existing Parking Lot Layout at Alfred W. Hanmer Elementary School

Some parents dropped their children off in the middle of the school parking lot southwest of the school building. **Figure 2** shows the existing parking lot layout at Alfred W. Hanmer Elementary School, with the teacher parking to the south east, and the general parking to the southwest. The entrance is from the south on Rosedale Street and the exit is to the north east on Francis Street and through the circulation of the southwest general parking lot. The decision to drop students off in the parking lot creates conflicts with students crossing between parked buses. During the morning drop-off, eight full-sized buses, one mini-bus and two vans arrived at the school parking lot drop-off area. This entrance on Rosedale Street is used for morning drop-offs because it is located at the side of the school, and exits onto Garden Street. Signs towards the side entrance direct buses while parents are directed into the left parking lot by two unconventional signs (**Figure 4**). Parents also drop off students at the Board of Education building parking lot on Francis Street.

- Some vehicles were observed cutting through Rosedale Street and the school parking lot immediately before school buses arrived in the morning. The SRTS team proposes a new school parking lot layout to separate the buses from the teacher parking and parent drop-off/pickup area. One concept is shown in **Figure 26**. This layout shows a separate bus area (to the north), with the handicap stalls and/or reserved teacher stalls in the same location as the existing layout near the side door. Buses would no longer be able to access the side entrance via Rosedale Street, but would access the side entrance via Garden Street. The west parking lot, south of the proposed bus access, would be one-way circulation accessible via Garden Street and Rosedale Street. This layout separates buses from parent pickup/drop-off lot, and provides a sidewalk from Garden Street to the side entrance for children. This concept provides a safer passage for children walking between the parking lot and school entrance without having to navigate between parked buses. The number of existing parking stalls shown is maintained with the new layout, and can be potentially increased. This layout reduces impervious pavement area.

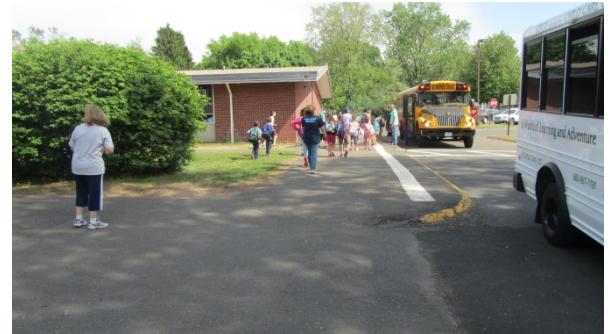
Alfred W. Hanmer Elementary School is situated in a suburban Wethersfield neighborhood. School begins at 8:55 a.m., but students are allowed to enter the building starting at 8:35 a.m. through the side entrance in the school parking lot accessed by Rosedale Street. Parents/adults are not allowed to enter through the side entrance, they are only allowed through the front door. Walkers and bikers tend to arrive around 8:35 a.m., while bussed students typically arrive around 8:40 a.m. While student drop-offs both by car and walking with parents started around 8:35 a.m., the highest concentration of students arrive from 8:45-8:55 a.m., as shown in **Figure 3**.

Figure 3: Drop-off Process on Rosedale Street

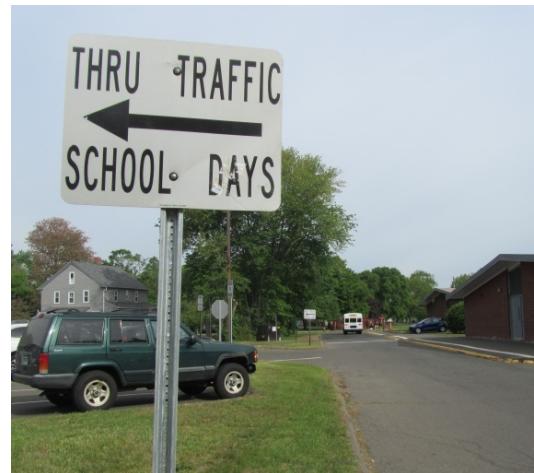
Figure 4: Sign to direct Parents in School Parking Lot

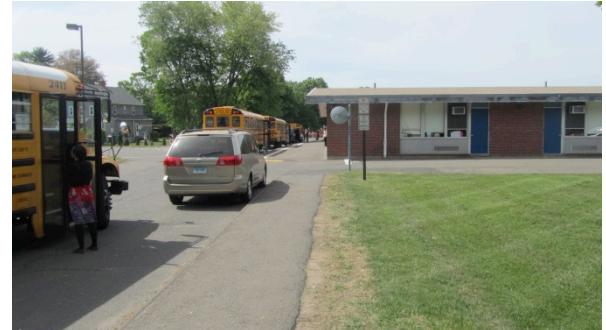
In general, the drop-off process functions rather well, with buses lining up along the side entrance and waiting for the first bell to ring to let the students off the buses. Some parents dropping off children were using the bus drop-off areas for parking, which had signs prohibiting parking in these areas (**Figure 5**). Some parents were also walking their children between the buses from the west parking lot to the school. Parents cause further congestion in the parking lot by preventing the buses from pulling into their drop-off areas.

Figure 5: Parents parking in prohibited bus drop-off areas

- Encourage law enforcement to increase police presence in order to monitor temporary illegal parking and drop-off. Place safety cones, bollards or saw horse in crosswalk to enhance awareness. This would prevent the tendency for children to cross between school buses. The permanent crosswalk can also be restriped to be situated behind the school bus drop-off/pickup area to encourage students to cross at a safer location. This can also be used to supplement the "THRU TRAFFIC" sign to assist with directing drivers away from the bus area as seen in **Figure 22**.

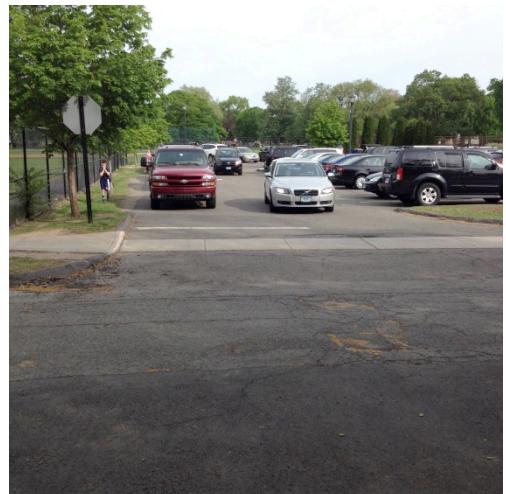
Figure 6: Student Pickup Dismissal Process

The school day at Alfred W. Hanmer Elementary School ends at 3:10 p.m. Hanmer's dismissal is staggered by grades, with bus dismissal and student pickup beginning at 3:10 p.m. The bus dismissal uses the side entrance to the school, while the student pickup occurs in the west parking lot and the sidewalk north of Rosedale Street south of the bus drop-off. Teachers park in both the east and west parking lot. During dismissals, students are escorted from the school to the bus pickup area by teachers. Some students were dropped-off/picked-up in the Board of Education building parking lot east of the school on Francis Street, as shown in **Figure 6**. While an adult escorted most students who walked home, there were isolated cases where students biked home alone or traveled in groups without an adult. During the assessment, a teacher was not seen assisting children across the drop-off/pickup area where vehicles are traveling along Rosedale Street, and in the two parking lots. This is not an ideal situation because the circulation of the parking lots creates potential conflicts.

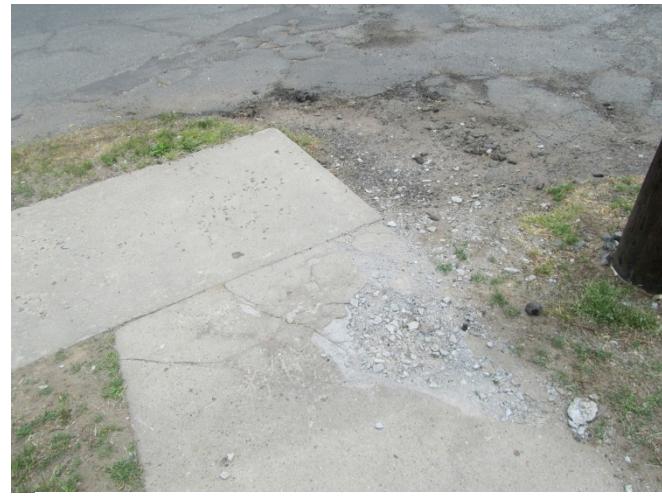
In general, the sidewalk pavement quality is in good condition, except for the pavement in front of the north sidewalk at the intersection of Hartford Avenue and Avalon Place on the west leg as shown in **Figure 9**. There is also fair pavement at the entrance driveway to the front of the school.

Figure 9: Hartford Ave/Avalon Place Broken Pavement at Handicap Ramp

- a. Crosswalk on south leg of Hartford Avenue at Avalon Place extends to a handicap ramp that is steep and not ADA compliant. It is recommended that this handicap ramp be regraded, and/or angled to be ADA compliant and detectable warning strips installed.

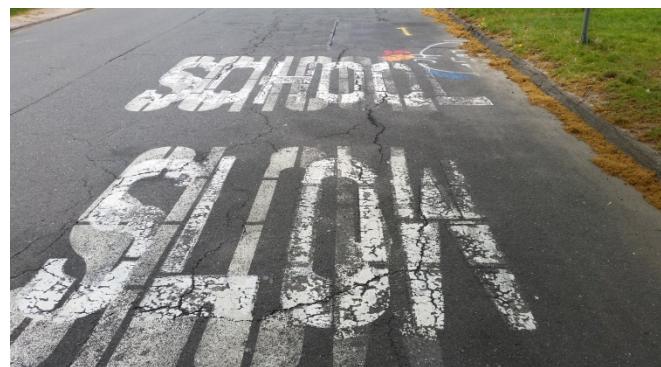
Figure 10: Poorly Painted SCHOOL SLOW Pavement Markings

- All "SCHOOL SLOW" pavement markings and crosswalks should be permanently removed (not blacked out) and restriped or replaced with SCHOOL ZONE pavement markings and the appropriate corresponding school zone signage to alert motorists that they have entered a school zone per Connecticut Department's School Zone Guidelines.

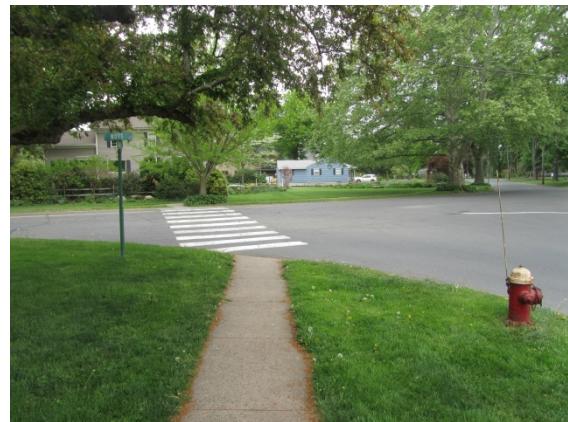
With the exception of some minor roads such as Willard Street and Meggat Park, all streets surrounding Alfred W. Hanmer Elementary School have sidewalks on both sides of the road. The majority of these sidewalks also were accompanied by grass buffers that on average were 4' wide or greater that separate the sidewalk and the roadway. The sidewalk pavement at all locations along potential walking and biking routes were in good condition, but visibility was obscured by trees or the intersection geometry at Garden Street/Nott Street (**Figure 11**).

Figure 11: Offset Garden Street/ Nott Street Intersection

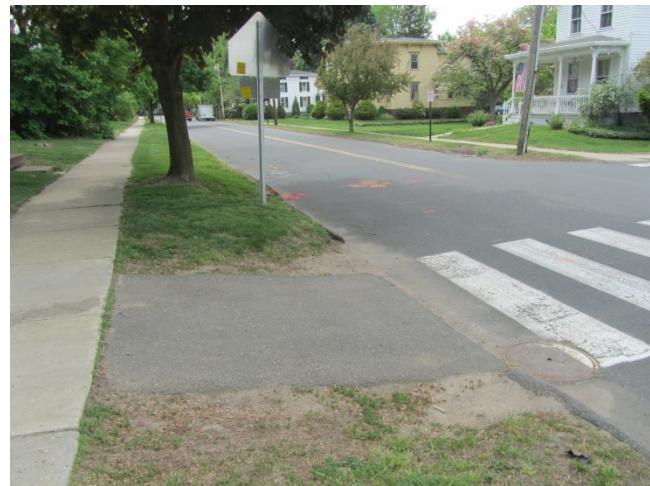
In general, the sidewalk pavement quality in Pedestrian Zone # 2 is in good condition. Pavement markings along this route are comprised of stop bars and crosswalks with double yellow lines on Hartford Avenue and Main Street. There are no edge lines along any roadways within this pedestrian zone. Similarly to Pedestrian Zone #1, bicyclists are forced to ride in a travel lane with no painted shoulders. The intersection of Hartford Avenue/Main Street has an uncommon stop control where the northbound approach is not controlled and the eastbound and southbound approaches are stop controlled. This uncommon stop control, in an area where pedestrians and bicyclist are present, can create confusion. Also there are "SCHOOL SLOW" pavement markings on both approaches to the school on Hartford Avenue which were painted on top of old pavement markings and are in poor condition. Lastly, even though the conditions along this route are acceptable for walking in this area, the crosswalks area all faded within this zone and the crosswalk at Hartford Avenue/Francis Street could be improved, as listed in **Table 2**. The crosswalk extends into a private driveway and the driveway slopes steeply down to the crosswalk and is not ADA compliant as seen in **Figure 13**.

Figure 13: Hartford Avenue/Francis Street Crosswalk in Private Driveway

- b. Crosswalk on north leg of Hartford Avenue at Francis Street extends to a private driveway. It is recommended that this crosswalk be shifted further north to direct pedestrians directly onto the sidewalk and install ADA compliant handicap ramps with detectable warning strips.

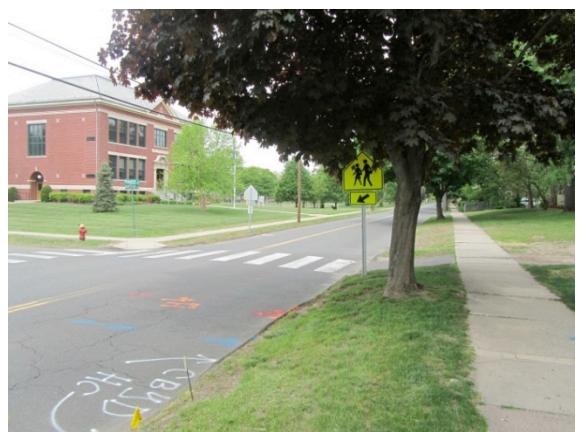
There are sidewalks on both sides of the street throughout Pedestrian Zone # 2, with the exception of Meggat Park where the southern half of the eastern side does not have a sidewalk. Additionally, sidewalks along both sides of Main Street consist of brick pavers. The grass strips along Main Street are approximately 10-15' wide, which serve as buffers between vehicular traffic and pedestrians using the sidewalk. Sidewalks are generally in good condition, with a few trees obscuring visibility of the SCHOOL CROSSING sign on the northbound approach of Hartford Avenue to Francis Street, as shown in **Figure 14**.

Figure 14: Vegetation Obscuring Visibility of SCHOOL CROSSING Sign on Hartford Avenue

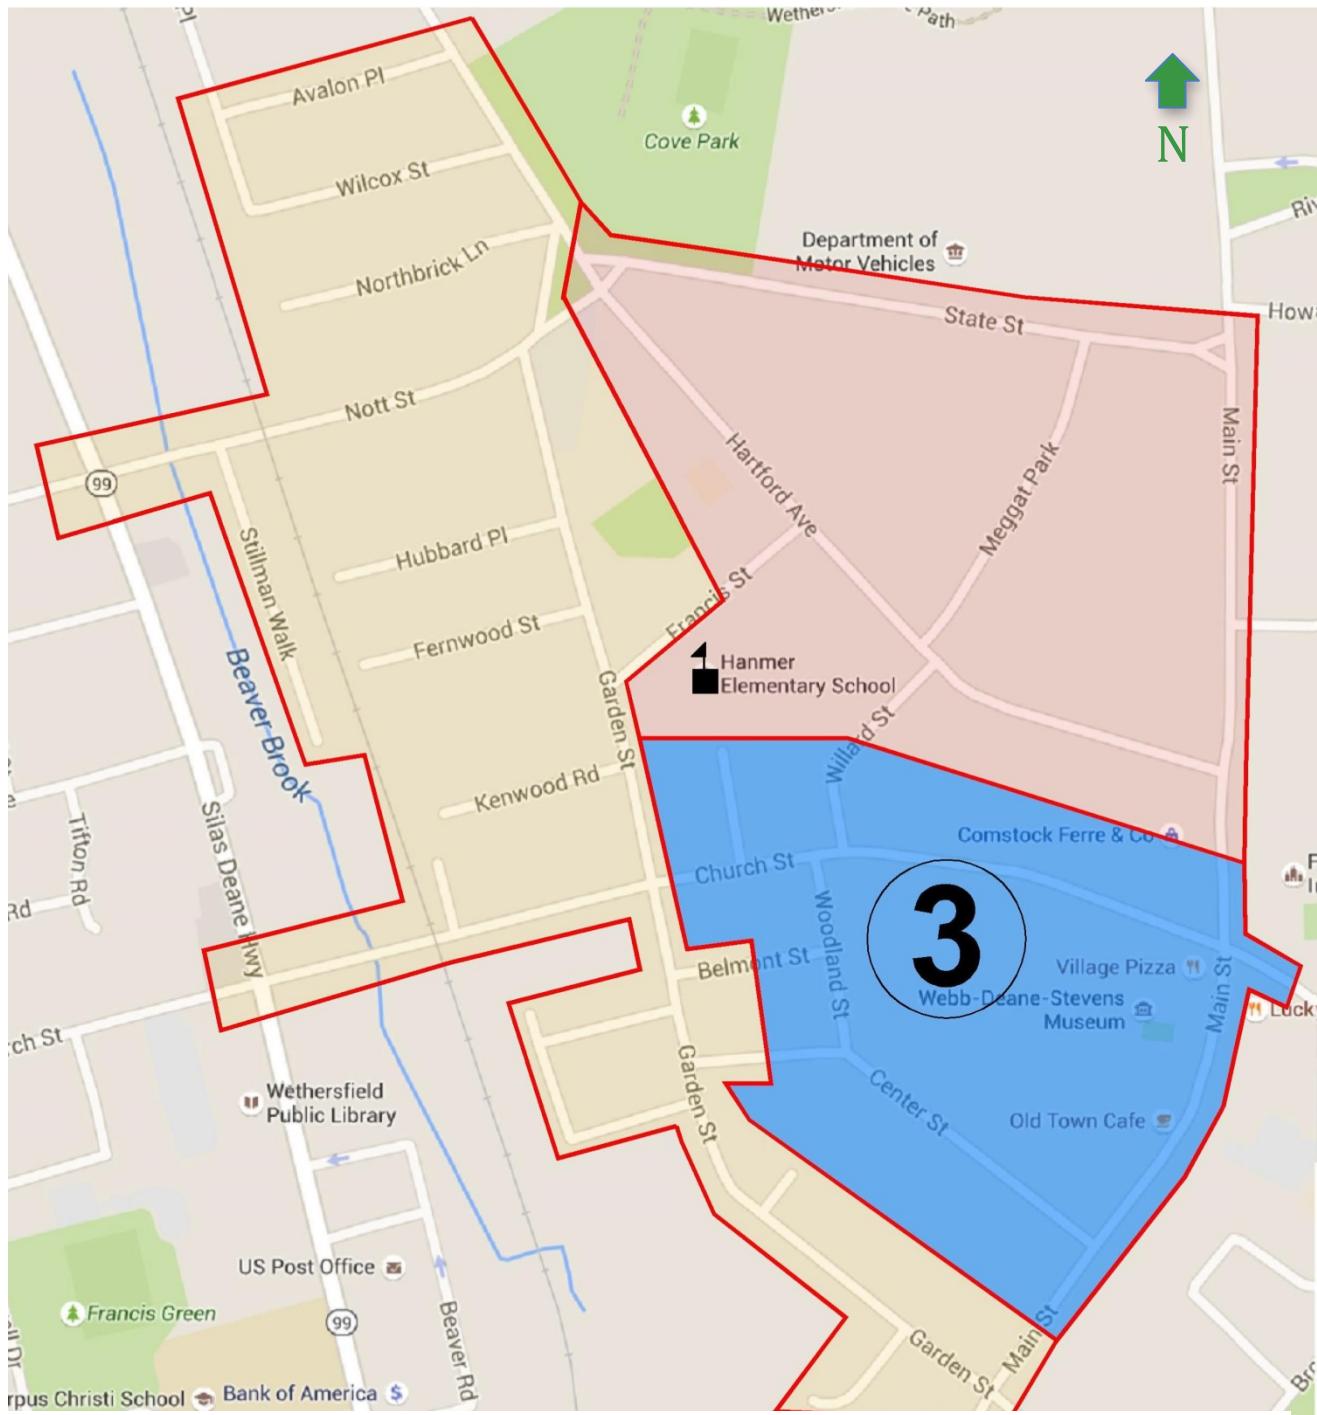
Figure 15: Pedestrian Zone # 3

Pedestrian Zone # 3 is bounded by Church Street to the north, Center Street to the south, Main Street to the east, and Garden Street to the west (blue fill). The main roads for pedestrian access to Alfred W. Hanmer Elementary School in Pedestrian Zone # 3 include Main Street, Church Street, and Rosedale Street. The longest walking route is approximately 0.5 miles long from the easternmost point on Main Street to the side entrance to enter Alfred W. Hanmer Elementary School, as shown in **Figure 15**.

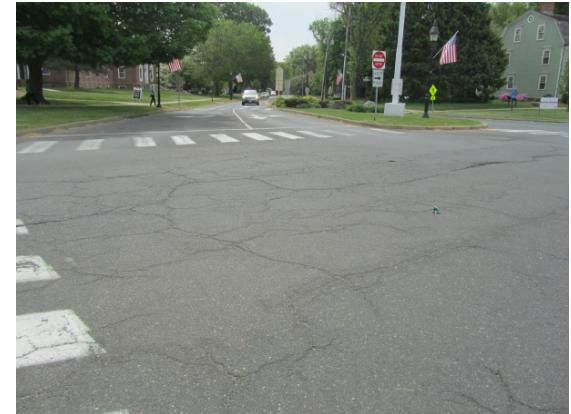
In general, the sidewalk pavement quality is in good condition in Pedestrian Zone #3. The intersection of Main Street and Church Street has traffic operation issues. Several drivers were observed not stopping on the east leg of the intersection where they have a stop sign, and other vehicles were seen stopping for both directions on Main Street where there are no stop signs. Potentially, the Town will develop improvements at this intersection to improve traffic operations.

Crossing at this location is potentially dangerous based on the length of the crosswalks which range from 74'-82' long. There is a pedestrian bollard on the north leg, but no center median refuge for the north leg. All crosswalks are faded, specifically the pavement markings at the intersection of Main Street and Church Street. The two sets of crosswalk pavement markings on the westbound approach of Church Street are faded as shown in **Figure 16**. The crosswalks at the Main Street/Church Street intersection connect to a center median on the east leg of the intersection, but do not have any handicap ramps as a refuge as noted in **Table 2**. Also noted in this table is a crosswalk at the intersection of Church Street and Rosedale Street which extends into a driveway. There are no edge lines along Main Street or any roads within this pedestrian zone, which is problematic for cyclists who would be forced to ride in a travel lane with no painted shoulders. Also there are "SCHOOL SLOW" pavement markings on both approaches to Rosedale Street on Church Street which were painted on top of old pavement markings and are in poor condition.

Figure 16: Main Street/Church Street Crosswalks

- At the intersection of Church Street and Main Street, vehicles were observed stopping on the northbound/southbound approach where there is no stop control, and vehicles not stopping on the eastbound/westbound approach where it is stop-controlled. This intersection also has fairly wide crosswalks with no pedestrian refuge, particularly on the north leg. The median island that is on the east leg does not have handicap ramps. Off-the-record information has indicated that the town will potentially be improving this intersection in the near future. The SRTS team recommends the town consider a roundabout to narrow the crossing distance for vehicles and provide a refuge (splitter islands) for pedestrians crossing this intersection.

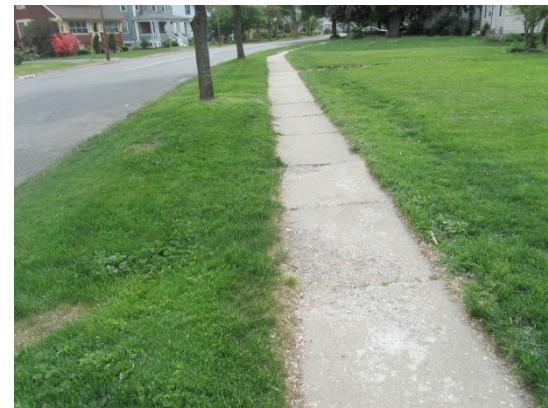
All streets have sidewalks on both sides of the roadway, with the exception of two residential cul-de-sacs on Garden Court and Old Smithy Lane; both of which have no sidewalks on either side of the road. All sidewalks are in good condition, with the exception of the southerly sidewalk along Church Street near Willard Street, which shows some signs of deterioration as shown in **Figure 17**. All sidewalks in Pedestrian Zone #3 have grass strips to serve as a buffer between traffic and pedestrians using the sidewalk that are approximately 7' or wider with the exception of Rosedale Street, which is approximately 3' wide.

Figure 17: Church Street South Sidewalk Weathering

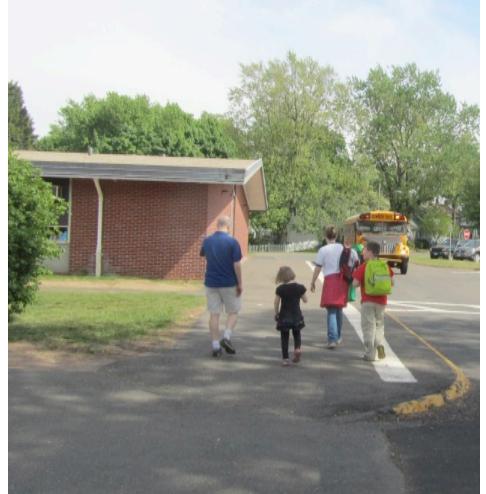
Figure 18: Parents Walking with Children

- Parents / guardians accompany their children by walking with them to school (**Figure 18**).
- Crossing guards stationed at high density traffic and walking zones. Crossing guards wore proper safety vests and used handheld stop signs.

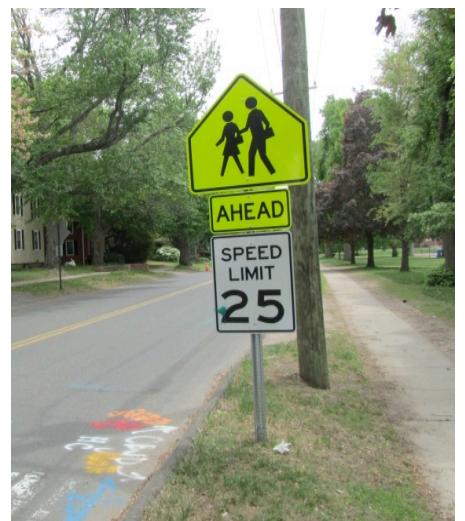
- New signs were installed with old signs, lowering the older signs and crowding the sign posts as seen in **Figure 19**. Some signs within the area were installed too low, where pedestrians can potentially hit the sign.
- The school traffic circulation pattern causes issues. Parents park near school buses and pass school buses during drop-off. Also during morning drop-off, parents enter Francis Street the wrong way to the front entrance (which is one way during drop-off and pickup), conflicting with pedestrians and buses.
- Crosswalks in all three zones are faded and several crosswalks extend into private driveways with either no handicap ramps or with steep slopes as noted previously in **Table 2**.

Figure 19: Newly Installed Signs Crowding Older Signs

- The STRS team recommends that over time all signage around the school be updated to meet MUTCD current specifications, particularly with regards to size, reflectivity, mounting height (MUTCD Figure 2A-2) and the fluorescent yellow-green color. The areas surrounding the school were recently updated with the MUTCD S1-1 School Crossing assembly signs with the arrow sub-plate, but are missing several advanced warning signs as mentioned previously. An example of this MUTCD S1-1 school sign is shown in **Figure 23**. According to the MUTCD, the school advance crossing assembly, with the "AHEAD" sub-plate, should be located 100 feet from the crosswalk. None of the school advance crossing assemblies has the "AHEAD" sub-plates. All of the STOP AHEAD signs (W3-1) are outdated at the intersection of Hartford Avenue and Main Street and lack proper reflectivity.

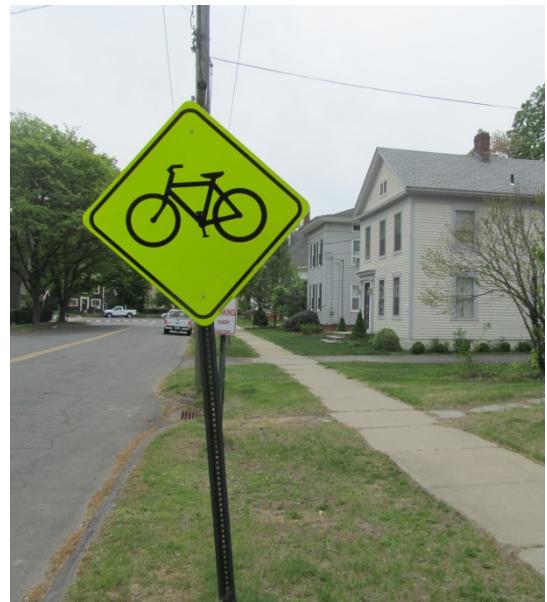
- All roads lack edge lines. All bike routes along Main Street or locations with bicycle warning signs (W11-1) lack edge lines (**Figure 20**).
- There is a lack of professional training and proper gear for teachers helping with arrival and dismissal processes. Teachers were not wearing safety vests.

Figure 20: Bicycle Crossing Sign without Edge Line Pavement Markings

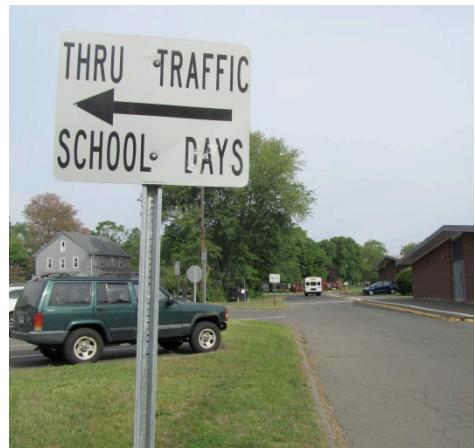
Figure 22: Sign Directing School Parking Lot Traffic

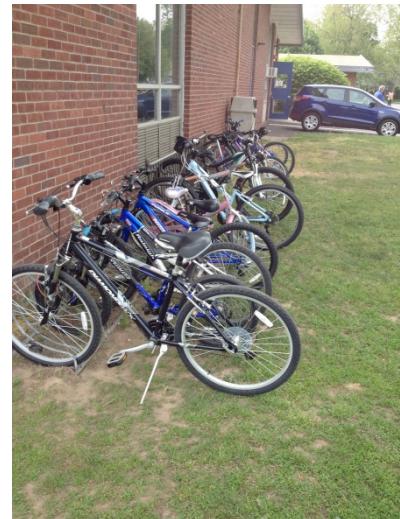
Figure 24: Bicycle Parking at School

- Most signs within the area are new yellow-green fluorescent as specified by the MUTCD.
- The school has a bike rack to accommodate cyclists.
- There are no apparent crime concerns within any of the pedestrian zones.

- Continue Walking Wednesdays, Walking / Biking contests, and mileage tracking throughout the year (**Figure 24**).
- Continue to encourage faculty and staff directing traffic to wear safety vests.

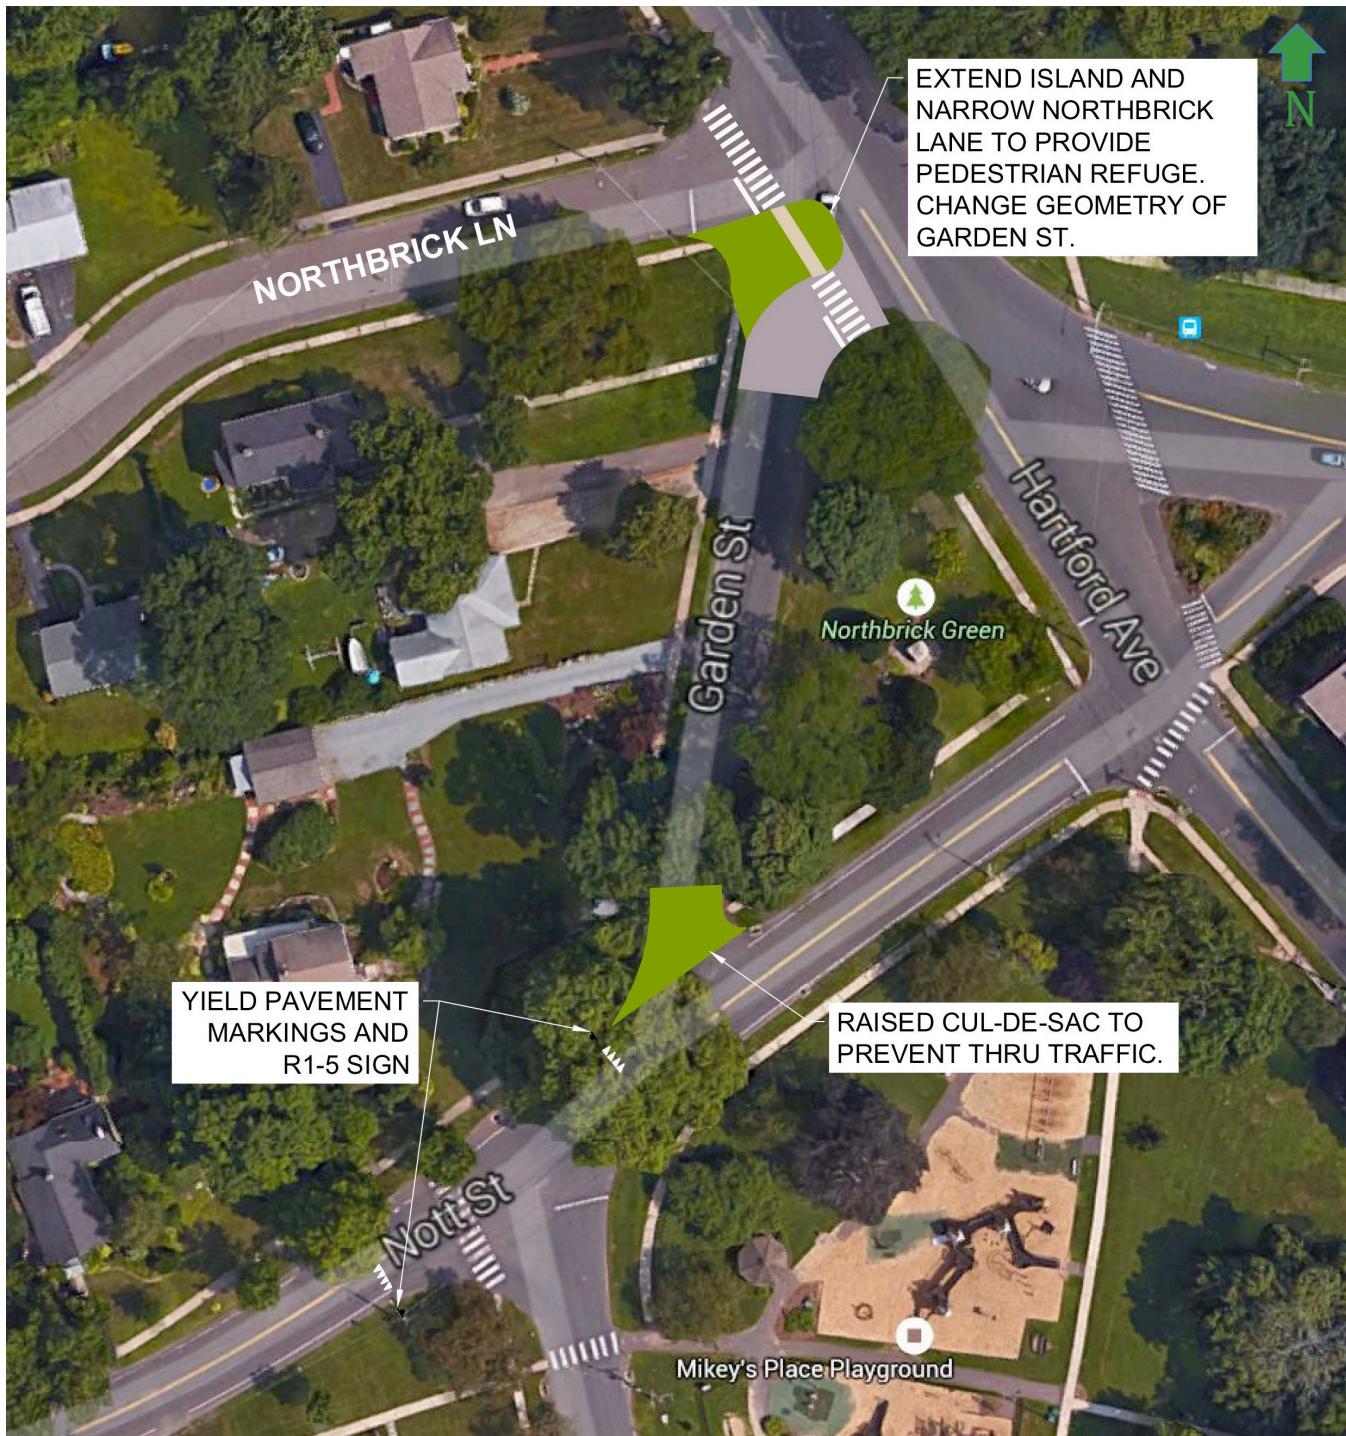
Figure 25: Garden Street (North) Cul-De-Sac Concept

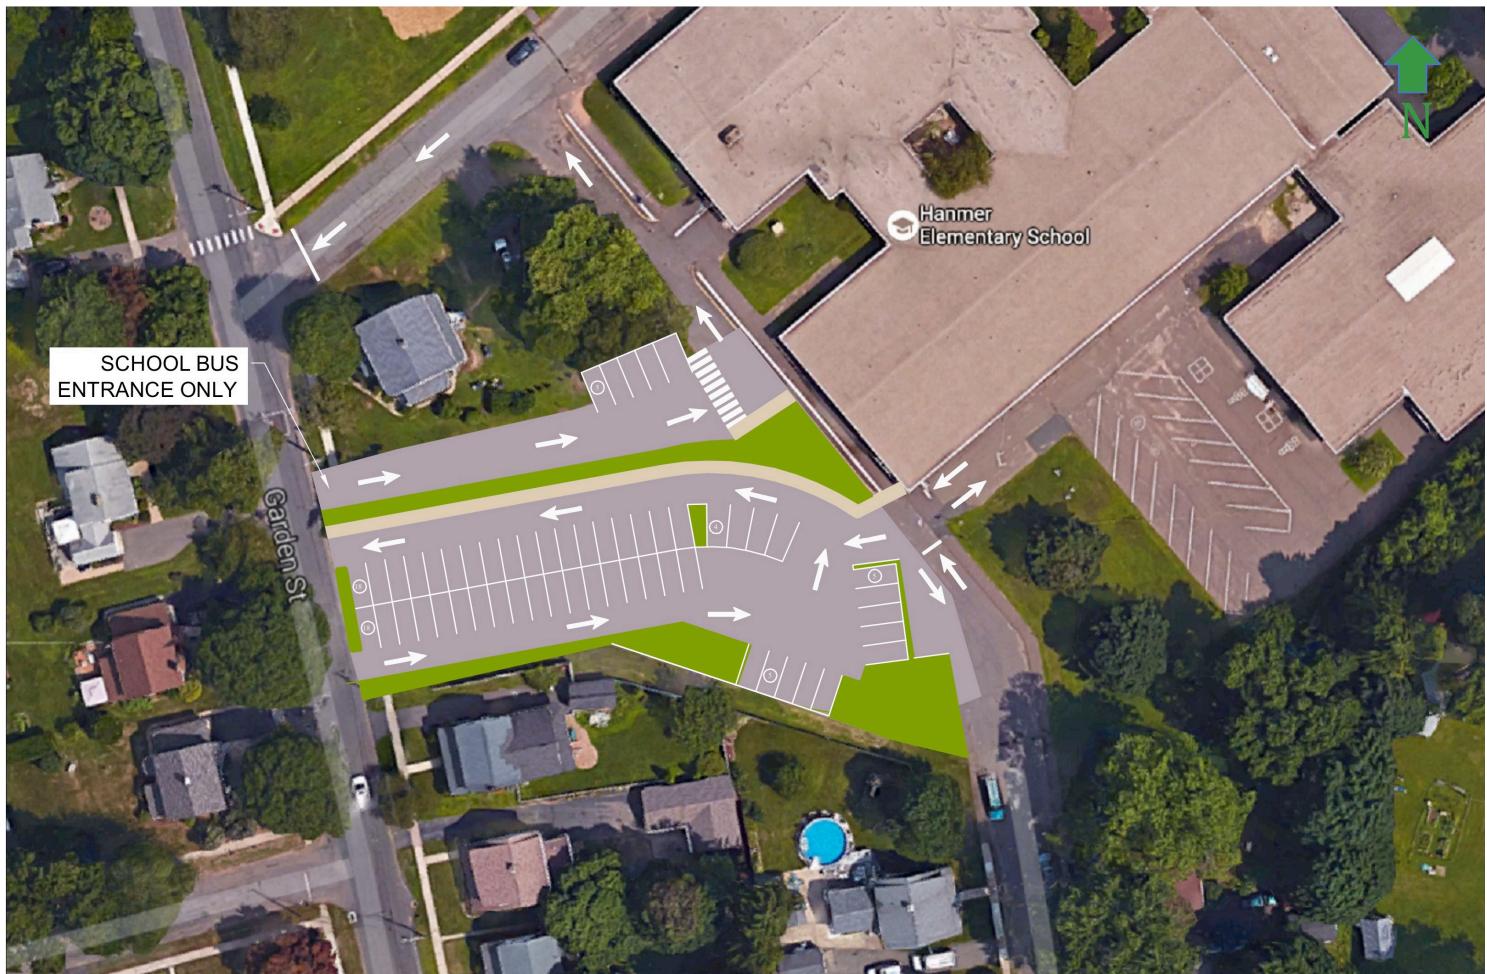
Figure 26: Alfred W. Hanmer School Parking Lot Concept
