# 2015 Safe Routes to School Walk Audit Findings Report

*Samuel B. Webb Elementary School  
Wethersfield, CT*

**Submitted By:**  
**VN Engineers, Inc.**  
**116 Washington Avenue**  
**North Haven, CT 06473**  
**Phone (203) 234-7862**

**October, 2015**

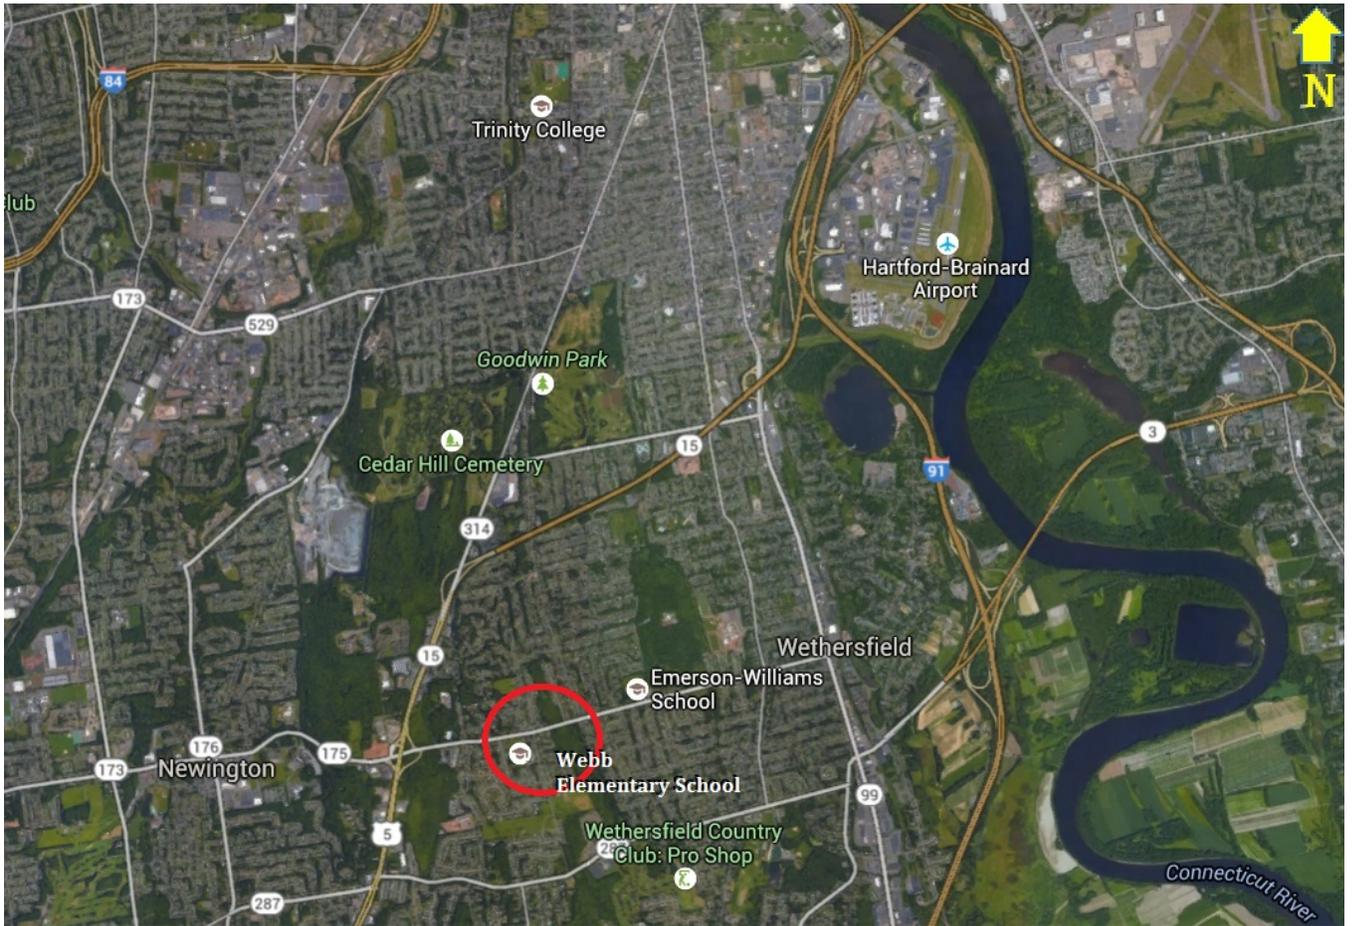
Figure 1: Samuel B. Webb Elementary School

**Figure 1** shows an overview of the Samuel B. Webb Elementary School study area.

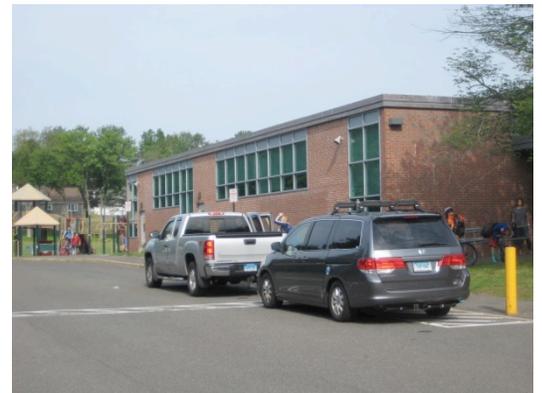
**Figure 2: Drop-off Process at South Lot Side Entrance**

Samuel B. Webb Elementary School is situated in a suburban Wethersfield neighborhood. The area between the school and Straddle Hill has few trees along Willow Street, with little shade provided in this area. School begins at 8:55 a.m., but students are allowed to enter the building starting at 8:35 a.m. through the front entrance facing Willow Street, the south side entrance, and the north side entrance in the school parking lots. Parents/adults are not allowed to enter through the side entrances, they are only allowed through the front door. Walkers and bikers tend to arrive around 8:35 a.m., while bused students typically arrive around 8:40 a.m. The highest concentration of students arriving was from 8:40-8:55 a.m., as shown in **Figure 2**.

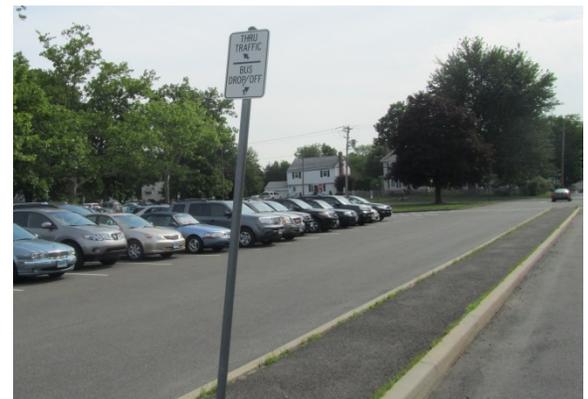
**Figure 3: Sign to direct Parents Away From Bus Drop-Off Area**

Most parents dropped off their children in the designated drop-off area south of the school, while others dropped their children off along Willow Street and in the north school parking lot. The decision to drop students off along Willow Street creates conflicts with students crossing between Glenwood Drive and the school, and when parents park in the north parking lot there are conflicts with buses. During the morning drop-off, seven full-sized buses, three mini-buses and one van arrived at the school's north parking lot drop-off area. Within the school's north parking lot, buses are directed by signs towards the side entrance while parents are directed into a thru traffic lane to the left of the bus drop-off area; these two areas are divided by a channelized island (**Figure 3**). Teachers park in the north lot.

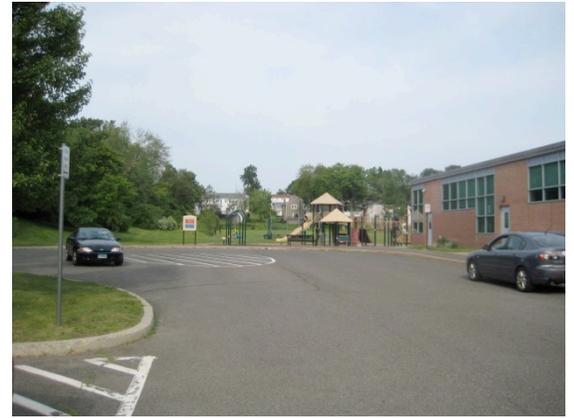
**Figure 4: Parents South Side Entrance**

In general, the bus drop-off process functions rather well, with buses lining up along the north side entrance and waiting for the first bell to sound to let the students off the buses. Most parents drop off children at the south side entrance, but some were parking in bus drop-off areas which had signs prohibiting parking in these areas. The south side entrance drop-off circulation is shown in **Figure 4**. Some parents were dropping off their children on Willow Street, even in areas with signs prohibiting parking, instead of pulling into the south side entrance.

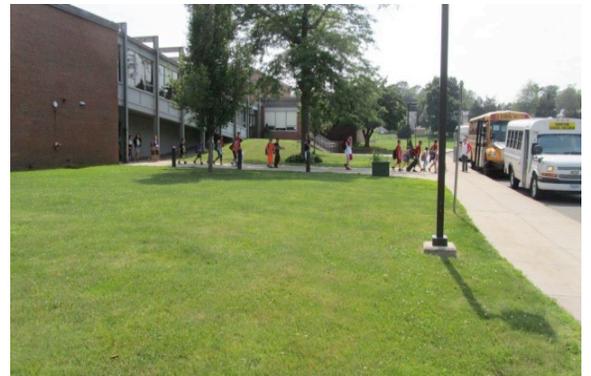
**Figure 5: Student Pickup Dismissal Process**

The school day at Samuel B. Webb Elementary School ends at 3:10 p.m. The dismissal is staggered by bus route location, with bus dismissal and student pickup beginning at 3:10 p.m. The bus dismissal process uses the north parking lot side entrance to the school, while the parent student pickup occurs in the south parking lot side entrance similar to morning drop-off. Teachers are situated at the school's north side entrance and coordinate with teachers outside located near the buses with handheld transceivers. During dismissals, the two teachers outside notify teachers inside which bus arrived, teachers inside then escort students from the school to the bus pickup area as shown in **Figure 5**. There were fewer parents entering the south side parking lot in the afternoon than the morning, with most parking on Willow Street to pick up students. Some were seen in no parking areas, or making U-turns within the crosswalk area of Glenwood Drive, conflicting with pedestrians. Very few children were observed walking to and from school.

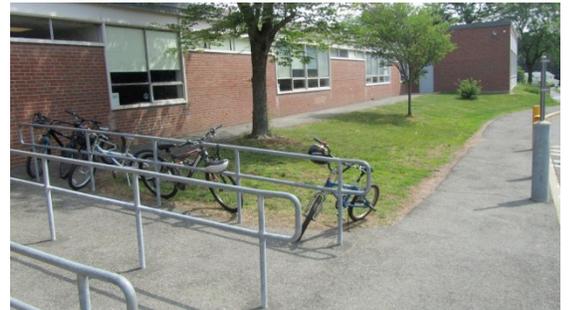
**Figure 6: Students Using South Side Entrance Railing as a Bike Rack**

There are no bicycle racks located at the south side entrance. At this location, bicycles were seen locked on the school's handicap ramp railing as seen in **Figure 6**. There is an existing bicycle rack at the north side entrance, which remained unused throughout the day. Most children who biked from north of the school were seen passing the school and entering from the south side entrance. The north side entrance was observed to only be used by children arriving by bus.

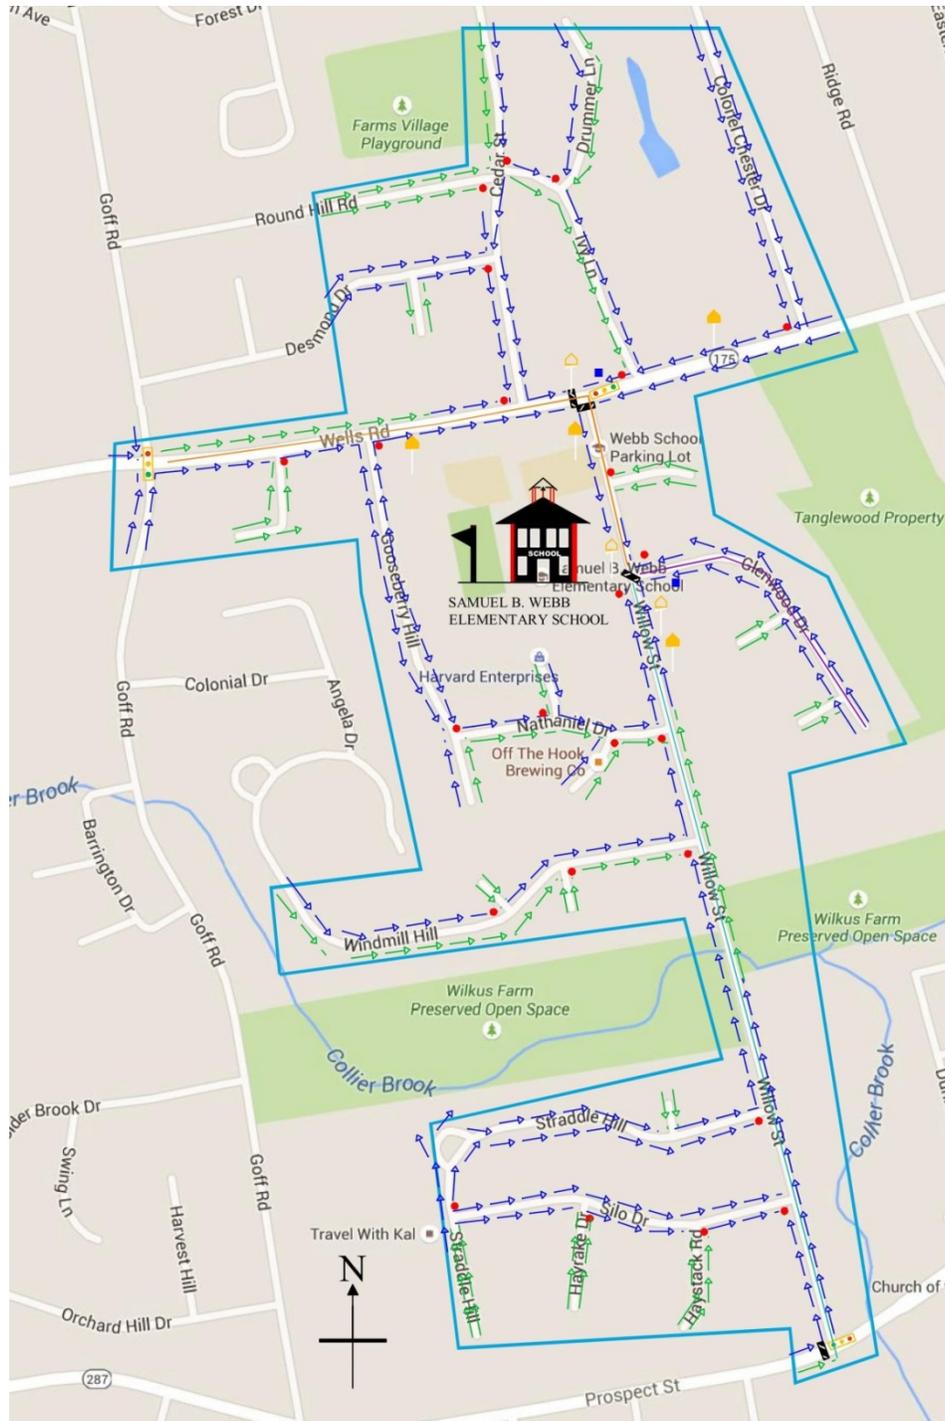
Figure 7: Samuel B. Webb Elementary School Plan Map

A plan map of the pedestrian routes to Samuel B. Webb Elementary School is shown in **Figure 7**. The walkable areas to Samuel B. Webb Elementary School are shown within the blue line. This area is bounded by Round Hill Road, Goff Road, Wells Road, Glenwood Drive, Willow Street, Colonel Chester Drive and Prospect Street. Since there is a high concentration of homes throughout, this area is assessed by dividing it into three zones: (1) north, (2) east, and (3) south.

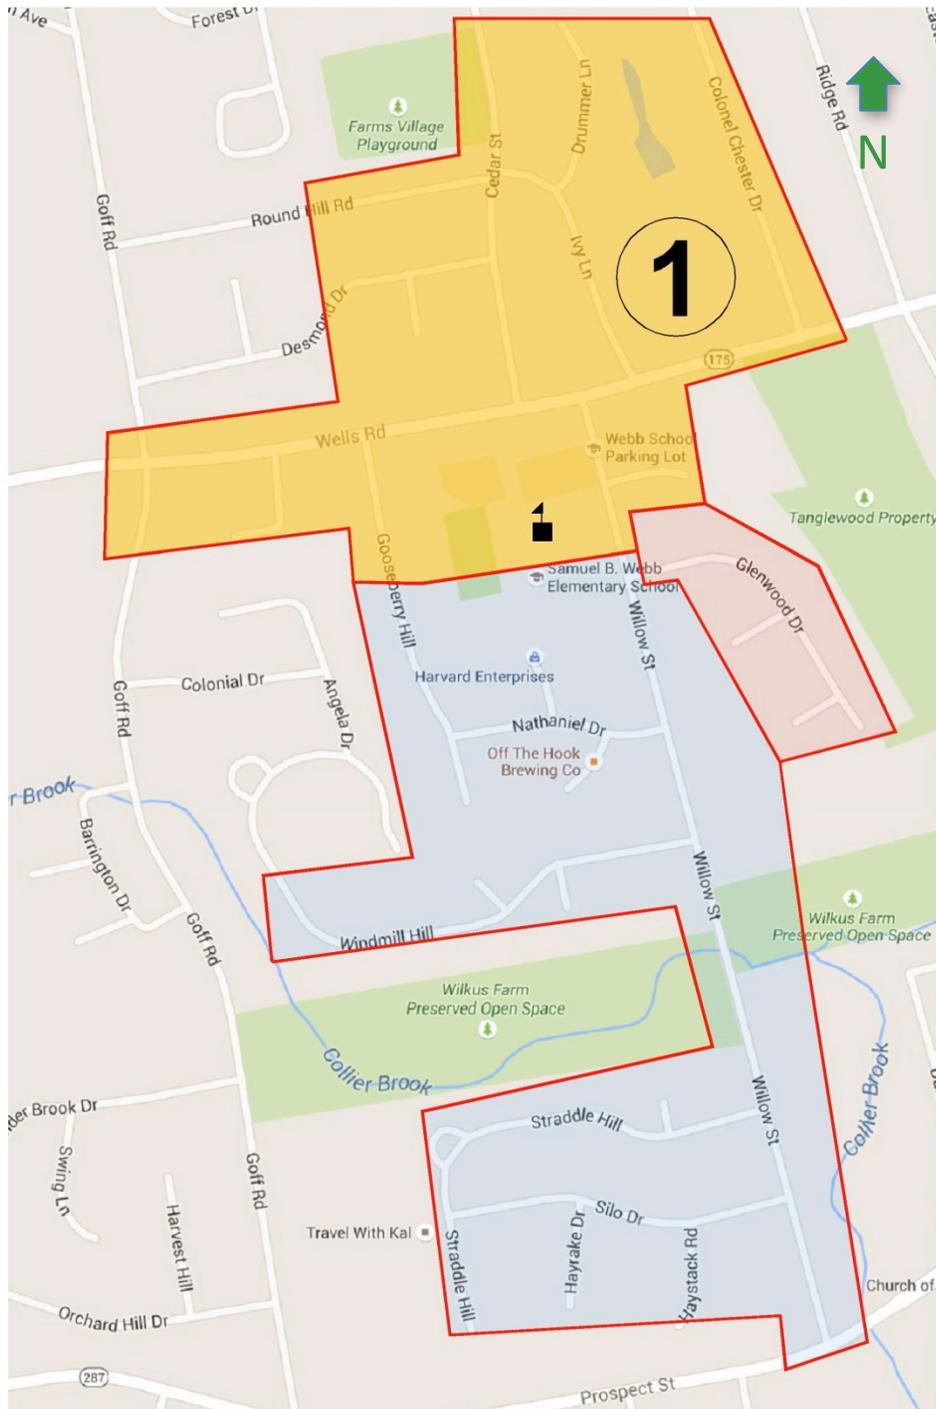
**Figure 8: Pedestrian Zone #1**

Pedestrian Zone #1 is bounded by Wells Road to the South, Goff Road to the west, Colonel Chester Drive to the east and Round Hill Road and Cedar Street to the north (orange fill). The main roads for pedestrian access to Samuel B. Webb Elementary School in Pedestrian Zone #1 include Willow Street, Wells Road, Goff Road and Cedar Street. From the furthest point at Goff Road, the route is approximately 0.5 miles to the front entrance of Samuel B. Webb Elementary School, as shown in **Figure 8**.

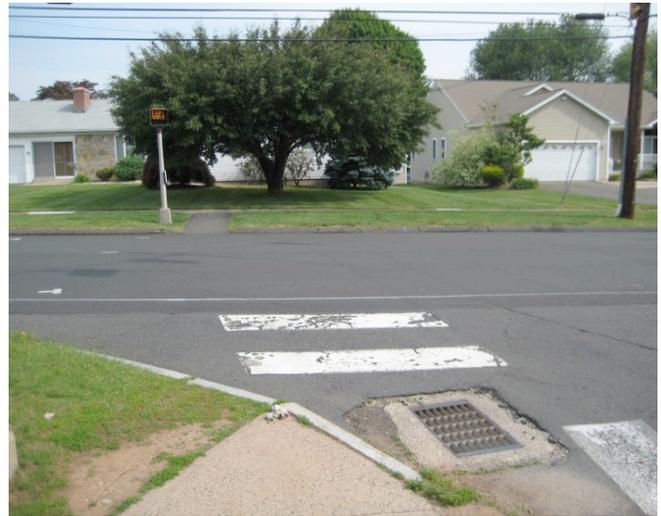
Figure 9: Wells Road at Willow Street Crosswalk

Pavement markings along this route are comprised of stop bars and crosswalks with double yellow lines on Wells Road and Willow Street. There are only edge lines along Wells Road within this pedestrian zone. There are no designated "SCHOOL ZONE" pavement markings or "SCHOOL SLOW" pavement markings within the area of the school. The crosswalk on Wells Road at the intersection of Willow Street appears to have been recently paved over; it currently does not extend the width of the roadway as shown in **Figure 9**.

- Restripe all crosswalks in compliance with MUTCD that are faded or missing within the school area, such as Wells Road/Willow Street and Glenwood Drive/Willow Street.

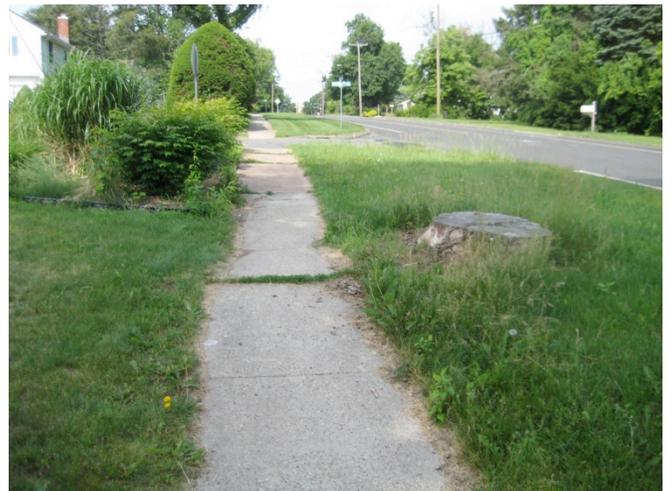
Figure 10: Upheaved sidewalk on Wells Rd West of Cedar St

There is one crosswalk location on Wells Road, east of Cedar Street approximately 200 feet west of the intersection with Willow Street, where there are handicap ramps on both the north and south side of Wells Road without a crosswalk between them. On the north side of Wells Road the sidewalk ends abruptly west of Cedar Street, and there are also upheaved sections of sidewalk on the south side as shown in **Figure 10**. Otherwise, the conditions along this route are acceptable for walking in this area. All crosswalks are faded and could be improved throughout all three zones, as listed in Table 2. Of the seven potential improvements for crosswalks and handicap ramps shown in **Table 2**, two apply to Pedestrian Zone # 1.

deteriorated/upheaved sidewalk throughout the school zone areas. Install new sidewalk in areas where sidewalk ends abruptly (1) east side of Willow Street between Nathaniel Drive to the Wilkus Farm Preserve; (2) Glenwood Drive to Wells Road; and (3) north side of Wells Road between Goff Road and Cedar Street. Install new handicap ramp and detectable warning strips where new sidewalk is constructed.

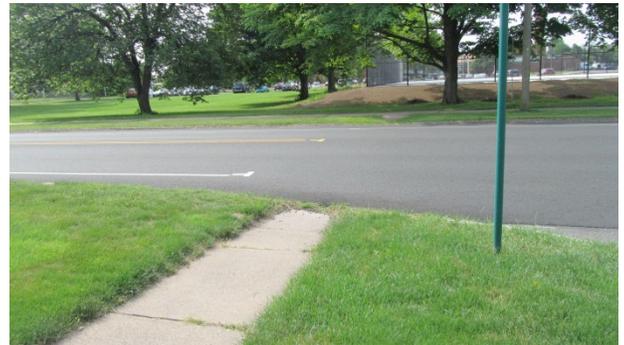
**Figure 11: Handicap Ramp in Close Proximity to Wells Road/Willow Street Signalized Intersection**

With the exception of some minor roads such as Ivy Lane, Round Hill Road, Drummer Lane, and Trivet Lane, all streets surrounding Samuel B. Webb Elementary School have sidewalks on both sides of the road. The majority of these sidewalks also were accompanied by grass buffers that on average were 4' wide or greater which serve as a buffer between the sidewalk and the roadway. The sidewalk pavement at all locations along potential walking and biking routes were good quality, but visibility was obscured by trees/intersection geometry at Wells Road/ Goff Road and some pavement was upheaved on Wells Road west of Cedar Street. There is also sidewalk on both the north and south side of Wells Road that extends towards curb ramps (without crosswalks) approximately 200 feet west of the intersection with Wells Road/ Willow Street (**Figure 11**).

These handicap ramps encourage pedestrians to cross in close proximity to a busy signalized intersection when they should be directed to the crossing guard at the signalized intersection.

- There are currently handicap ramps on both the north and south side of Wells Road approximately 200 feet west of the signalized intersection with Willow Street, which encourages students to cross a busy intersection away from the crossing guards.

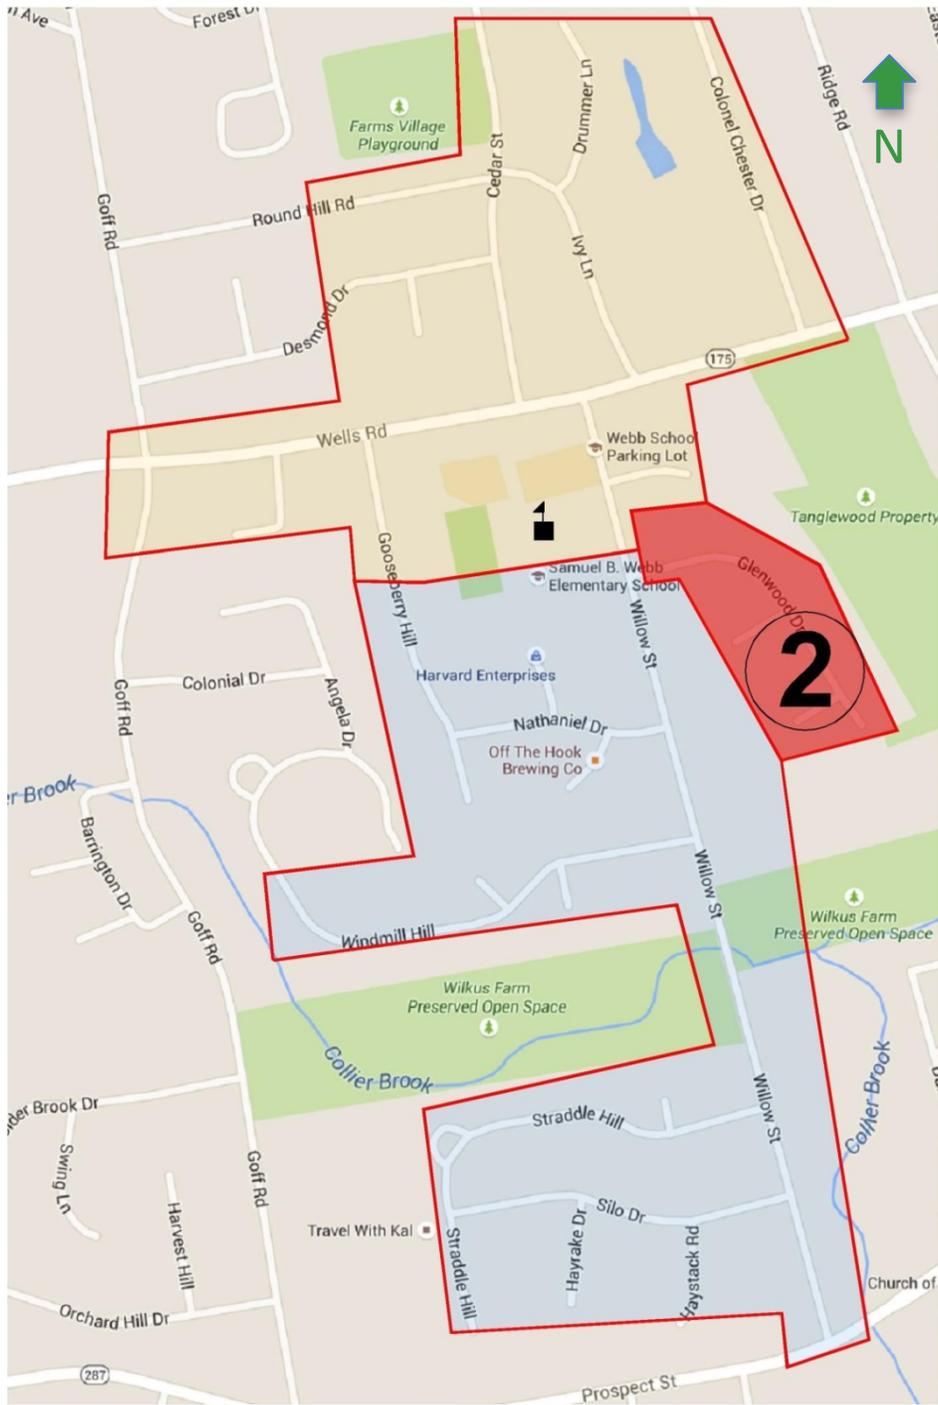
Figure 12: Pedestrian Zone # 2

an Zone # 2 is bounded by Willow Street to the west and Glenwood Drive to the east (maroon fill). The main roads for pedestrian access to Samuel B. Webb Elementary School in Pedestrian Zone # 2 include Glenwood Drive and Willow Street. The longest walking route is approximately 0.1 miles long from the easternmost point on Glenwood Drive to the front entrance of Samuel B. Webb Elementary School, as shown in **Figure 12**.

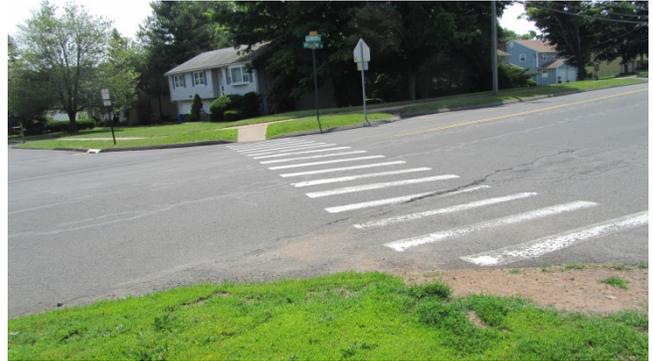
**Figure 13: Willow Street/Glenwood Drive Crosswalk in School's South Driveway**

In general, the sidewalk pavement quality in Pedestrian Zone # 2 is in good condition. Pavement markings along this route are comprised of stop bars and crosswalks with double yellow lines on Willow Street. There are no edge lines along any roadways within this pedestrian zone. There are no designated "SCHOOL ZONE" pavement markings or "SCHOOL SLOW" pavement markings within this pedestrian zone. The crosswalk that crosses Willow Street at the intersection of Glenwood Drive extends diagonally from the south side of Glenwood Drive to the north side of the school's south driveway as shown in **Figure 13**. This creates conflicts with parents exiting the driveway and children crossing the street. Lastly, even though the conditions along this route are acceptable for walking in this area, the crosswalk at Willow Street/Glenwood Drive is faded and could be improved, and the handicap ramps at the northeast and southeast corner of the intersection are both very steep, as listed in

**Table 2.** The northeast handicap ramp does not extend to a crosswalk on the north or east leg of the intersection nor does it extend to a handicap ramp on the west side of Willow Street.

- e. Regrade the handicap ramps on the east side of Willow Street at Glenwood Drive to be ADA compliant and realign the southeast corner to align with the northeast handicap ramp. Install a new handicap ramp on the northwest corner of the intersection that aligns with a second handicap ramp on the northeast corner, remove the diagonal crosswalk and install crosswalks on the north and east leg of the intersection. Consider installing yield lines and corresponding “Yield Here to Pedestrians” sign (R1-5) or a similar sign, at least 20 feet in advance of the crosswalk for both approaches. Install edgelines along Willow Street to provide defined shoulders for bikes to travel along and to provide traffic calming in the immediate school area. This concept can be seen in **Figure 24**.

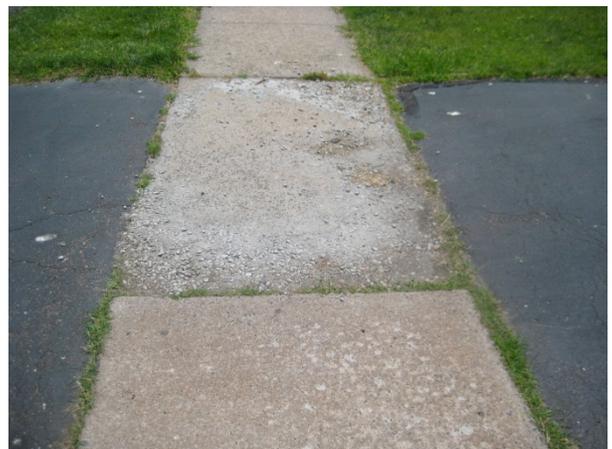
**Figure 14: Broken Sidewalk through a driveway on Glenwood Drive**

There are sidewalks on both sides of the street throughout Pedestrian Zone # 2. The grass strips along Glenwood Drive are approximately 4' wide or more which serves as a buffer between traffic and pedestrians using the sidewalk. Sidewalks are generally in good condition, with the exception of a section of sidewalk that extends across a driveway to the north which shows signs of deterioration as shown in **Figure 14**.

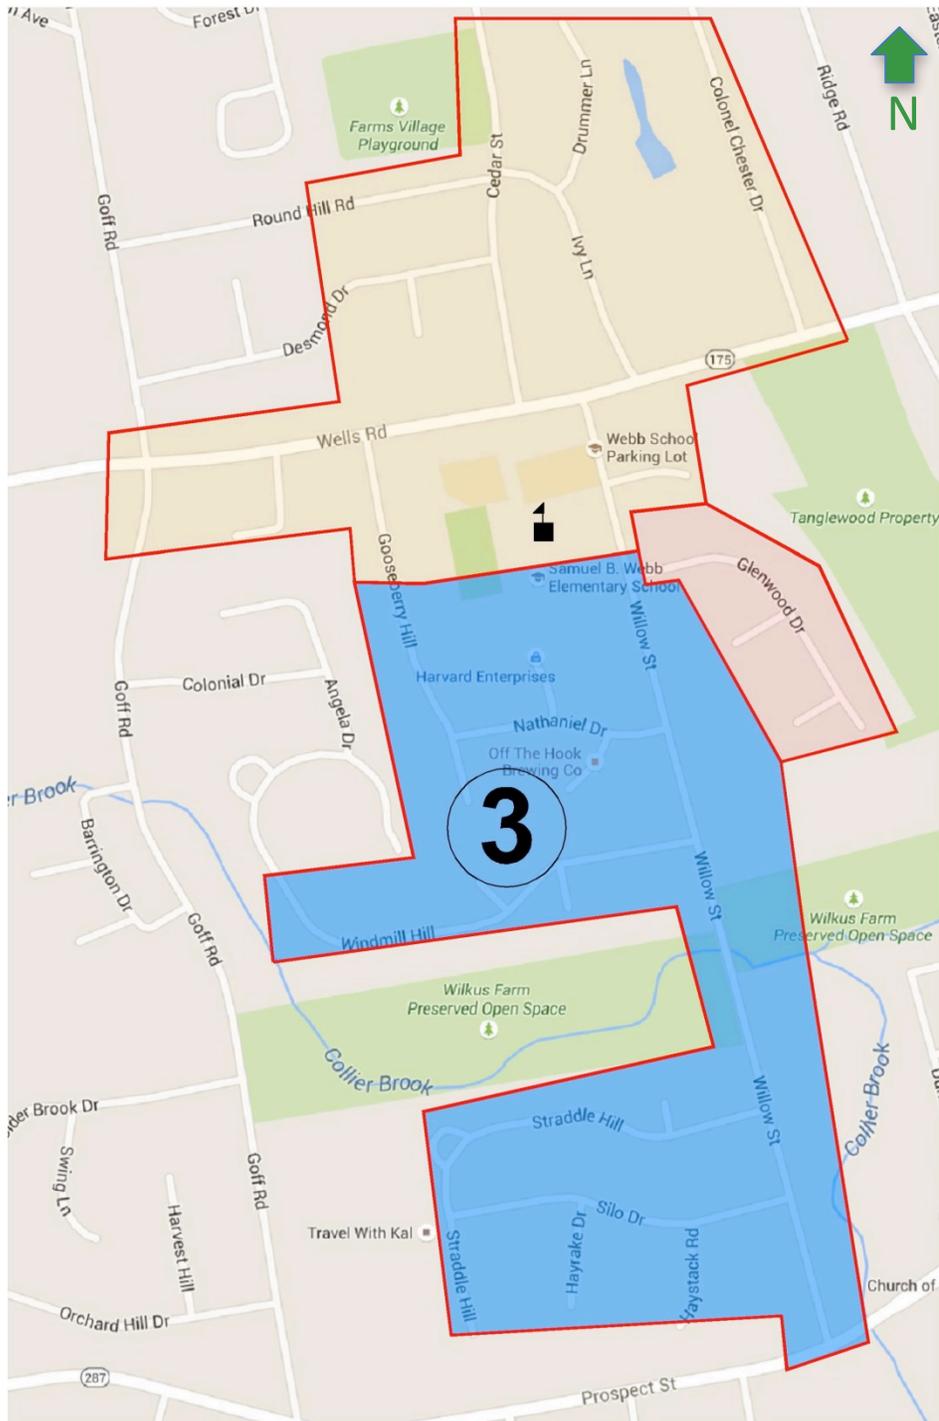
Figure 15: Pedestrian Zone # 3

Pedestrian Zone # 3 is bounded by Nathaniel Drive to the north, Prospect Street to the south, Willow Street to the east, and Gooseberry Hill, Windmill Hill and Straddle Hill to the west (blue fill). The main roads for pedestrian access to Samuel B. Webb Elementary School in Pedestrian Zone # 3 include Willow Street and Prospect Street. The longest walking route is approximately 0.5 miles long from the southernmost point on Willow Street at Prospect Street to the front entrance to enter Samuel B. Webb Elementary School, as shown in **Figure 15**.

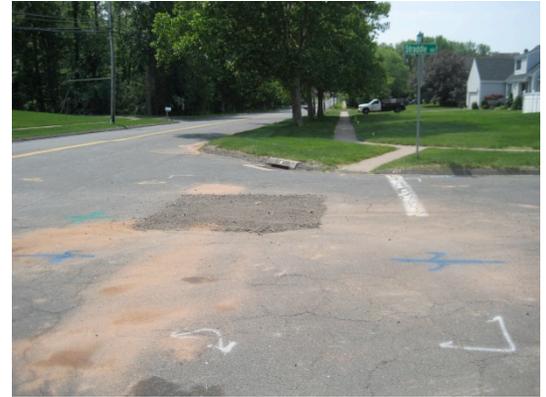
**Figure 16: Roadway Condition at Willow Street/Straddle Hill Road**

In general, the pavement quality is in good condition in Pedestrian Zone #3, with the exception of Straddle Hill Road which shows signs of patching as shown in **Figure 16**.

Pavement markings along this route are comprised of stop bars and crosswalks with double yellow lines on Willow Street. There are no edge lines along any roadways within this pedestrian zone. There are no designated "SCHOOL ZONE" pavement markings or "SCHOOL SLOW" pavement markings within this pedestrian zone. Lastly, even though the conditions along this route are acceptable for walking in this area, the crosswalk within this zone at Willow Street/Prospect Street on the west leg is faded and could be improved and the handicap ramp north of this crosswalk is deteriorated, as listed in

**Table 2.** The south side at this intersection has a pedestrian push button that is outdated and there are no sidewalks or handicap ramps. The push button is located in the grass strip.

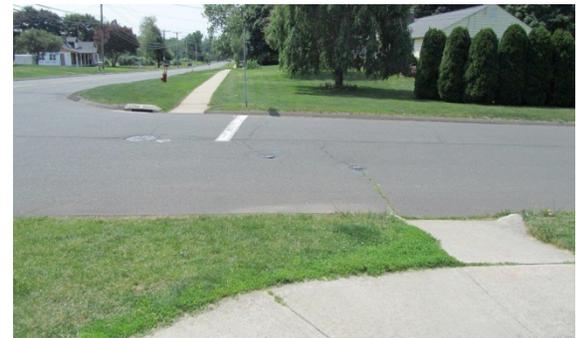
**Figure 17: Offset Handicap Ramps at Nathaniel Drive**

Within this pedestrian zone, Straddle Hill and Silo Drive have sidewalks on both sides of the roadway, and all other major streets have sidewalk on at least one side of the roadway. Willow Street has continuous sidewalk on the west side of the roadway, with partial sidewalk on the east side. There are no sidewalks south of Nathaniel Drive to the Wilkus Farm Preserve, nor do they exist from 140 feet north of Glenwood Drive to Wells Road. The handicap ramp on the north side of Nathaniel Drive is offset from the south handicap ramp by 14 feet as shown in **Figure 17**. There is also a handicap ramp on the north side of Prospect Street which is in poor condition at the intersection with Willow Street, and none on the south side. No handicap ramp on the south side of Prospect Street makes it difficult for some pedestrians to access the pedestrian push button. All sidewalks are in good condition, with the exception of the handicap ramp on the north side of Prospect Street which shows some signs of deterioration. All sidewalks in Pedestrian Zone #3 have grass strips approximately 4' or wider to serve as a buffer between traffic and pedestrians.

- c. The handicap ramps at Nathaniel Drive are currently offset by 14 feet. Replace the handicap ramp located on the north leg with one in line with the south ramp.

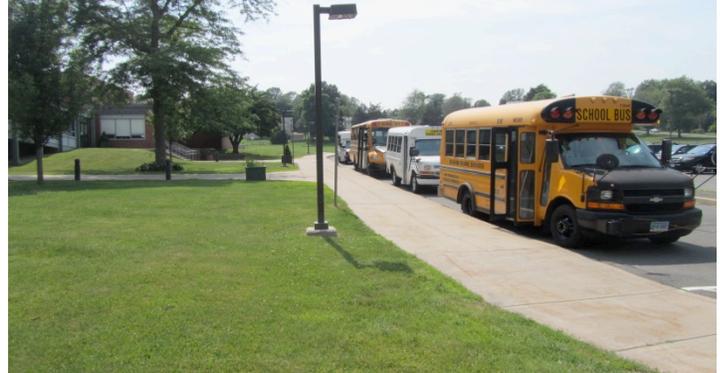
Figure 18: School Buses Lined up Waiting for Dismissal

- The bus dismissal process is also orderly and bused students are dismissed by bus route at the north side exit of the school where the school buses are located (**Figure 18**).
- Most of the walking routes in the immediate area of the school are through residential neighborhoods and have posted 25 mph speed limits, with the exception of Wells Road and Willow Street which have higher posted speeds.
- Most signs within the area are new yellow-green fluorescent as specified by the MUTCD.
- The school has a bike rack on the north side of building to accommodate cyclists.
- There are no apparent crime concerns within any of the pedestrian zones.

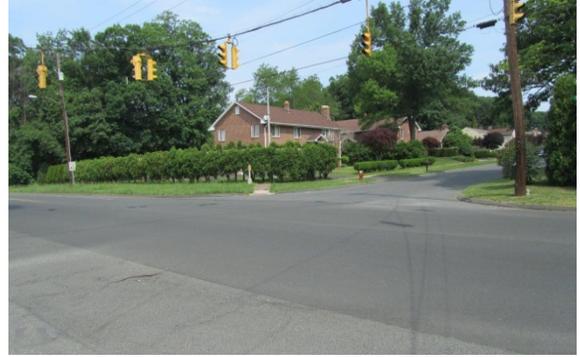
**Figure 19: Lack of Safety Measures at the Intersection of Goff Road/Wells Road**

- Due to limited through streets in the area, pedestrians are forced to walk longer distances to access the school. There is no direct path to school from nearby residences located directly behind school, such as Nathaniel Drive.
- The intersection of Goff Road and Wells Road lack: pedestrian signal heads (the existing push buttons change the traffic signal heads), sidewalk on the north side of the roadway, crosswalks, and stop bars for all approaches except for the south leg. Also, the northwest apex handicap ramp is angled towards the center of the roadway without a clear crossing pathway as seen in **Figure 19**. There are also overgrown hedges along the north side of Wells Road at this location.

- Trim vegetation at the intersection of Wells Road and Goff Road and install new crosswalks at the signalized intersection of Wells Road and Goff Road to increase safety and to clarify crossing points for pedestrians and drivers. This intersection is included for signal replacement in State Project 171-402, currently scheduled to be constructed in 2019. The Department will coordinate with the Town regarding the design once the project commences.

- Install handicap ramps, detectable warning strips, regrade the handicap ramps and/or relocate the crosswalk as noted below:
  - a. Install a new handicap ramp with detectable warning strips on the northwest and southwest corners at the intersection of Wells Road (Route 175) and Goff Road.

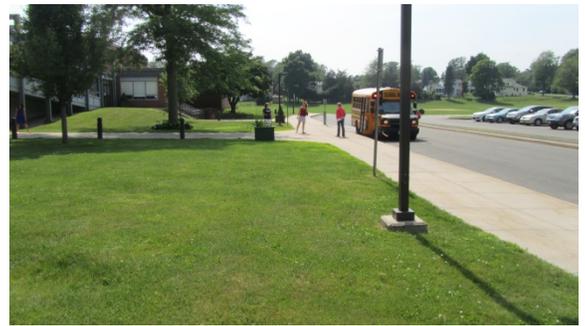
**Figure 20: Teachers Not Wearing Safety Vests During Dismissal Process**

- There is a lack of proper gear for teachers helping with arrival and dismissal. Teachers were not wearing safety vests (**Figure 20**).
- The SRTS team can come to the school and talk to the PTA and introduce the SRTS program. They will offer pedestrian and bike training, while helping to inform parents about the safest way to pick-up and drop-off their children. The team could also further explain the drop-off and pick-up processes.

- Walking Wednesdays, Walking / Biking contests, and mileage tracking could help continue encouraging walking and biking to school throughout the year.
- Encourage faculty and staff members to assist parents during drop-off and pickup process. If they are directing traffic, ensure they wear safety vests.

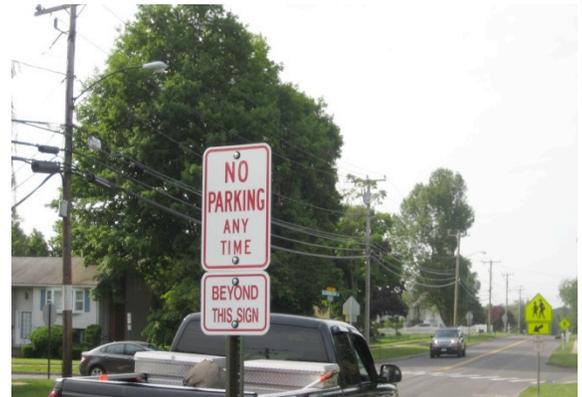
**Figure 21: No Parking/Student Drop-Off Sign**

- The SRTS Program provides free pedestrian and bike education for students and parents. The SRTS committee could contact the SRTS team to arrange follow up training or check the CTDOT website after September 2016 for more information<sup>2</sup>. These education programs would clarify for parents where to walk their children within the school bus drop-off/pickup area.
- Attend a Driver and Passenger Educational program to clarify drop-off/pickup procedures to new parents at the beginning of the school year, taking into account the arrival of the buses during drop-off. This will reduce issues with parents parking in school bus drop-off areas or in general no parking areas (**Figure 21**). This might also establish a safe means of entering the south side entrance instead of parking along Willow Street.

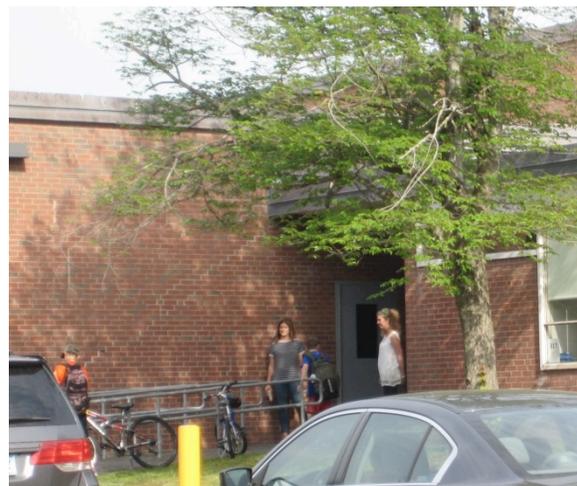
Figure 23: Biking Students Arriving to School at South Lot Entrance

- Walking Wednesdays, Walking / Biking contests, and mileage tracking could continue the encouragement of walking and biking to school throughout the year (**Figure 23**).
- Encourage faculty and staff directing traffic to wear safety vests.
