A Study of Revitalization Opportunities in **OLD WETHERSFIELD**

July 2013

Prepared for TOWN OF WETHERSFIELD
by CME ASSOCIATES, INC.

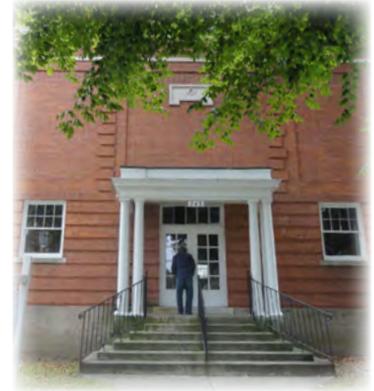
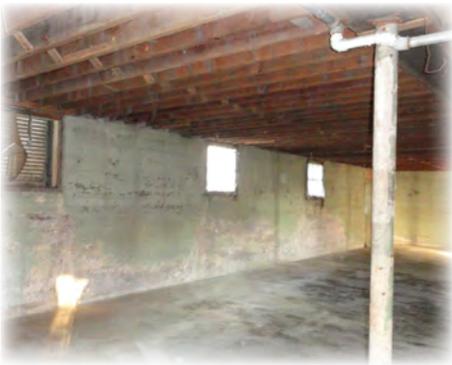
A monumental two stories in height with a partially exposed full basement, the brick and structural clay tile bearing wall structure is rectangular in plan with a flat roof obscured by a high parapet wall. Oriented east/west, the overall building footprint is 40' by 70'. The front and first side bays of the simple brick mass are articulated with Federal style detailing including horizontal brick banding of the first story base and brick quoins at the front corners and between brick panels of the second floor. Cast stone detailing includes a cartouche, a framed panel with the Masonic square and compass, centered high in the middle front panel of the second floor. A cast stone band above the articulated brick panels of the front portion of the building, and the window sills, are the only other cast stone elements. The top of the building below the parapet is defined by a wide frieze and a deep, dentilated metal cornice through which gutters associated with scuppers in the parapet wall pass. The rear and sides of the building are simply articulated by recessed brick panels into which the windows are set.

The basement is characterized by exposed concrete foundation walls, two rows of steel columns dividing the space in thirds, window openings in the upper half of the wall where it is exposed above grade, and two egress doors served by exterior concrete stairs within bulkhead structures. At present, there is no interior stair access to the first floor although a framed opening exists on the rear wall of the space.

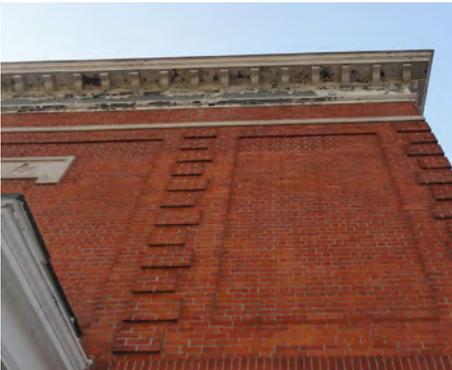
Constructed of durable masonry, steel and heavy timber, the exterior structure and interior framing appear to be in excellent condition. Evidence of water damage on the wood floor of the second level warrants investigation of the condition of the built up roofing material to determine if it can be repaired, or requires replacement. Exterior brickwork and mortar is in very good condition although the façade should be cleaned to remove biological growth which will damage the mortar joints over time. Doors and windows are original and should be repaired as necessary and not replaced. Cosmetic painting of the cornice and portico is necessary as the paint has failed on the fascia. Minor wood repair is required at the portico column bases. The primary required repair is to the concrete stairs on the southwest side of the building which should be totally removed and rebuilt.

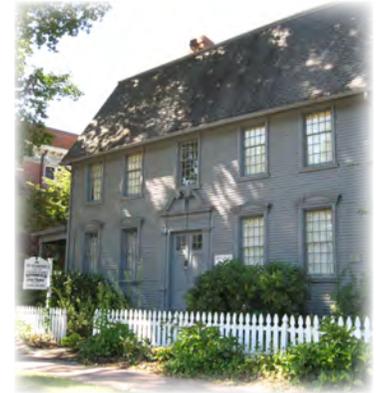
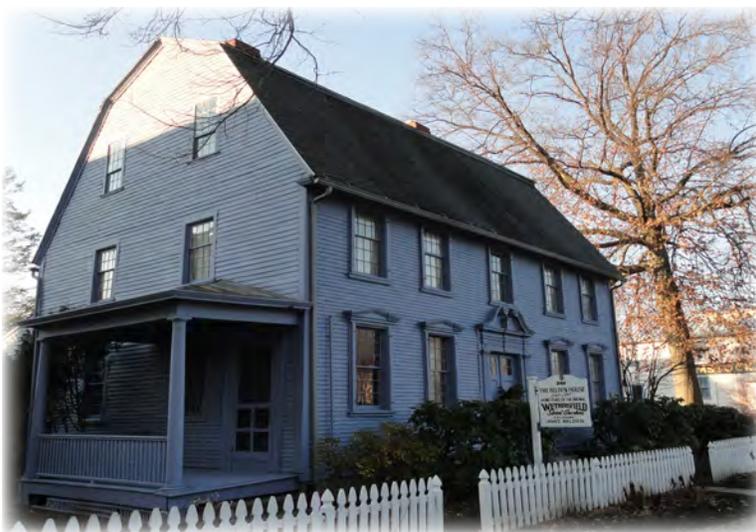
A five-bay structure with the gambrel roof ridge running parallel to the street, the defining feature of the front façade is the handsome, center entrance with a pair of three-paneled doors framed by pilastered trim with a deep entablature and broken scroll pediment. Other features of the front façade include wood clapboard siding with a narrow exposure to weather, pedimented first floor window heads, 12 over 12 first floor windows and 8 over 12 second story windows. Chimney stacks are visible between the first floor windows on either side of the front door confirming that fireplaces serve front and back rooms on both the north and south.

A small, hipped roof open porch has been added to the south side and is served by a door from the southeast parlor. A similar hipped roof porch on the northern elevation is set back from the front façade and serves as an entrance to the northwest room through an enclosed single-story addition which wraps around the rear of

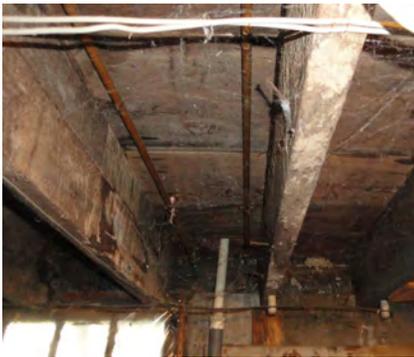
As the structural engineer's report describes, the foundation of the original house has been rebuilt. What was once a masonry foundation is now a cast-in-place concrete foundation that defines a full basement under the entire building footprint. First floor framing was replaced with sawn lumber, possibly when the foundation was rebuilt, resulting in a sound and level first floor system. The report also states that while the gambrel roof framing is undersized according to today's standards, it carries the imposed loads without signs of any distress.

The house has been well cared for over the years and exhibits exterior finishes in extremely good condition including the clapboard siding, windows, asphalt shingle roof and decorative trim. Interior finishes are also in very good repair. Currently the majority of the structure is used for residential purposes while a portion of the first floor houses a small food service kitchen, takeout and dining area. The central stair to the second floor residential use is currently accessible by the front door to accommodate a separation of use.

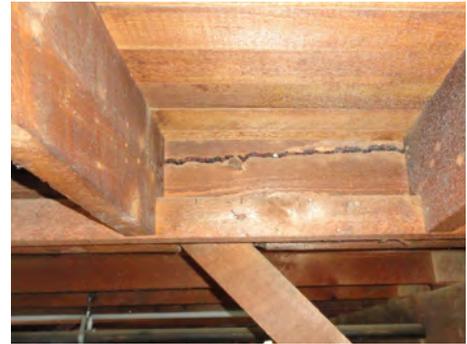
include mortise and tenon joints that have either failed over time or require reinforcement to meet current building codes. Some structural members need replacement due to past water damage, but overall, the retail complex to the east of the site is in very good condition and can readily be improved to meet a variety of new uses.

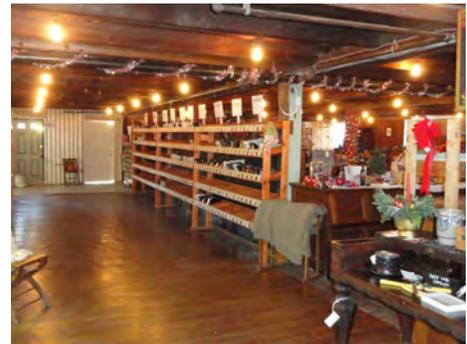
The barn complex on the western portion of the property is comprised of several post and beam structures including some very early barns. The western-most barn is in the worst condition and will necessitate significant repair and replacement of historic fabric in order to be safely utilized for any purpose. This is also the case with the Horse Barn oriented east to west on the northern property line and connecting several other barn structures. The central and iconic three story Hay Barn is in very good condition and has been finished on the lower two floors for use as office and storage space. The adjacent Onion House is also in good condition as is the contemporary connecting space that links it to the nineteenth century Tack and Wagon Barn. Based on future intended use, each of these buildings will need to be thoroughly investigated to insure that structural members and joinery are suitable for the new purpose.

Architecturally, exterior materials have been repaired and maintained to reflect their original appearance. Regulatory review by the Old Wethersfield Historic District Commission has insured that recent modifications have been made appropriately. Minor repairs to siding and trim, especially in the barn complex are necessary and should be made in-kind. As interior spaces are developed and potentially outfitted with mechanical and electrical systems, care should be taken to respect the integrity of remaining historic fabric.

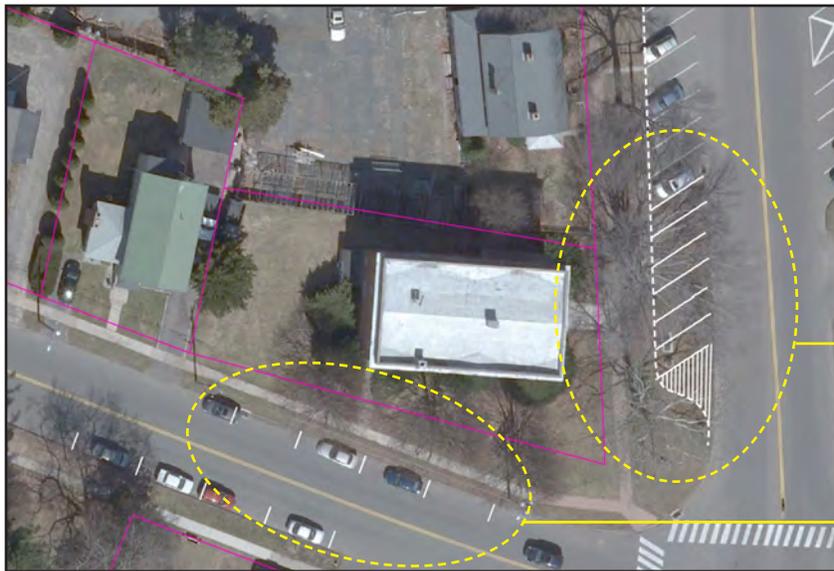
Figure 1

Additional parking could be provided along Main Street by expanding the public diagonal spaces to the south in front of the Masonic Hall. The diagonal spaces currently end in front of the Belden House. While diagonal parking should not get any closer to the intersection than 20-30 feet, there appears to be adequate space to add 5-6 new parking spaces in front of the Masonic Hall. An existing bench that is street-side of the sidewalk will have to be relocated, but the two large trees in front of the Masonic Hall appear to be sufficiently away from the street line to be unaffected by the parking expansion. A similar extension of diagonal parking area took place on the opposite side of Main Street, in front of Lucky Lou's restaurant, to allow for additional public parking accommodation.

Extend parking in front of Masonic Hall. Six additional spaces.

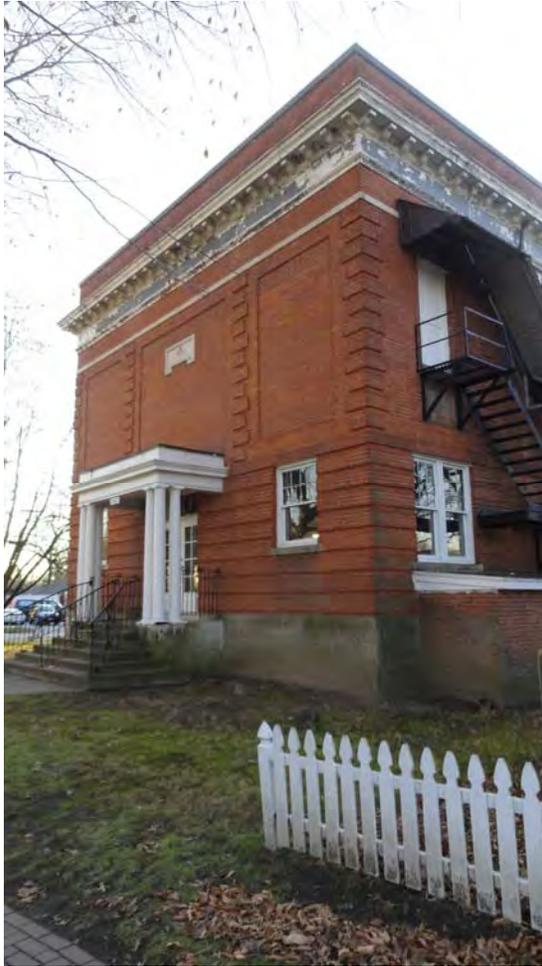
At the time of the inspection, all interior partitions had been removed and the existing roof and floor framing was clearly visible. The roof framing consists of rough-sawn 2x wood purlins on steel trusses. No sagging or obvious signs of distress were observed. The first floor framing consists of rough-sawn 2x wood joists framed into ledgers on large timber beams which are then supported on round steel columns. Second floor framing was designed to create a clear and open space at the first floor level through the use of steel beams framing into the brick bearing walls with 2x wood joists spanning between the beams. It is evident that the framing was sized for large assembly loads and is in sound condition. It is anticipated that the existing framing would be suitable to support the required loads, given a future use of retail, assembly, or residential space.

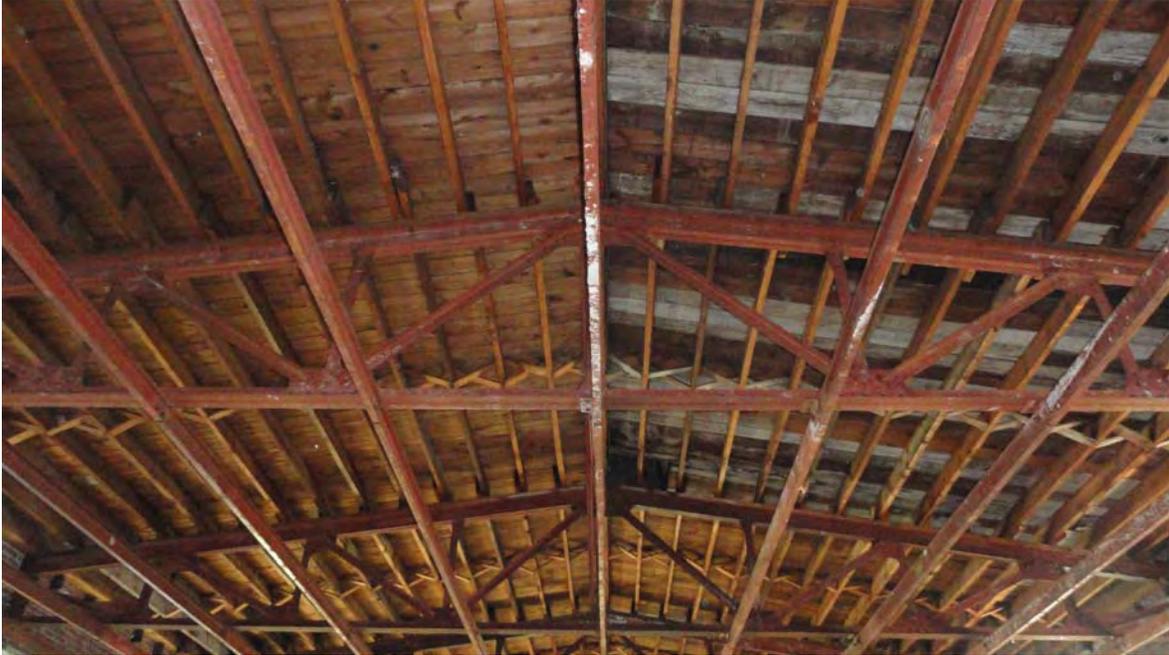
In several areas however, buckling of the oak flooring and water stains were observed which indicates past or present water intrusion through the roof. It is recommended that the wide-board roof sheathing and sub-floor be inspected for water damage and replaced as necessary.

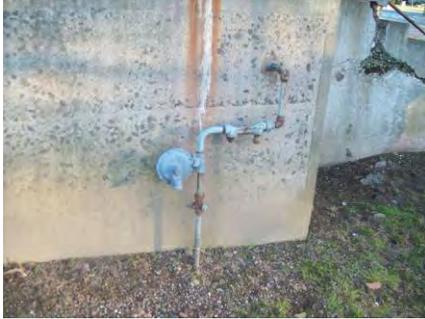
The building is equipped with a natural gas riser from the street. The natural gas meter and main piping have been removed.

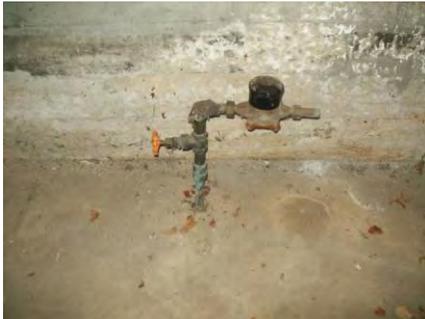
Domestic cold water enters the building in the basement. The meter and main piping have been removed.

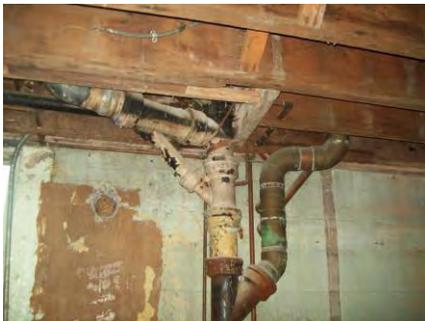
Sanitary main and branch piping is located throughout the building. The majority of the piping appears to be in bad condition. Replacement is warranted due to age and condition.

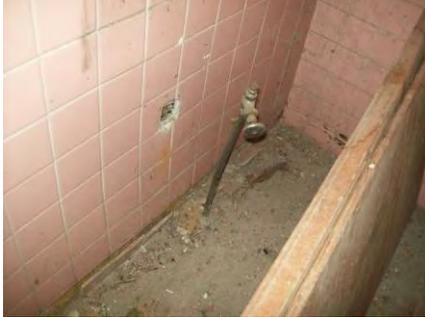
An existing bathroom has domestic pipe stubs that appeared to be abandoned in place. Replacement is warranted due to condition.

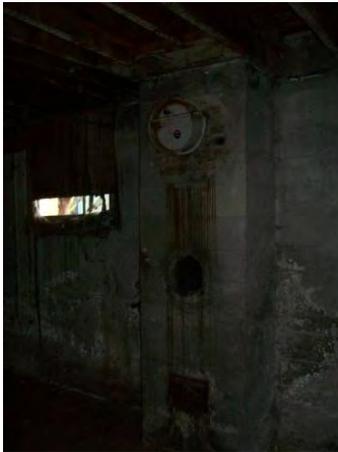
The only mechanical component in place is an atmospheric flue damper that is routed to the chimney. Removal is required.

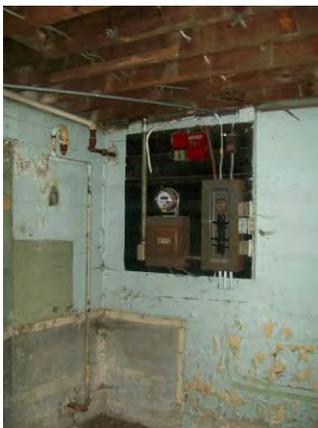
The electrical service for the building is routed overhead from a utility pole located on Church Street. Service conductors are routed down the side of the building in conduit and terminate in an antiquated panel located in the basement with the electrical meter located adjacent to it. Both the panel and meter enclosure are in very poor condition and require replacement.

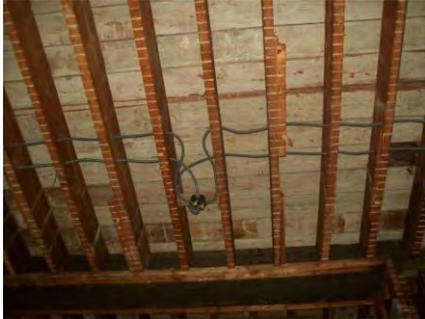
Branch circuit wiring for the building appeared to have been run in flexible metal conduit. Although some flexible metal conduit remains in place, it appears that the vast majority has been removed.

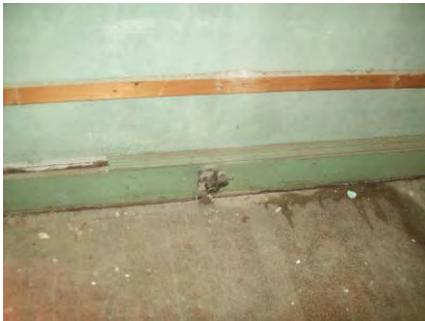
Electrical switches and most of the receptacles within the building were removed. Only a few receptacles installed in the baseboard remained and were in poor condition.

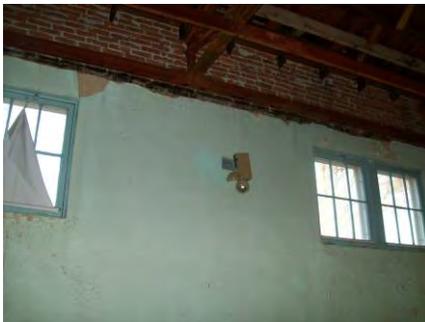
The only lighting remaining within the building are a damaged dual head emergency lighting unit, antiquated exit sign and a few exterior light fixtures in poor condition. All other light fixtures have been removed.

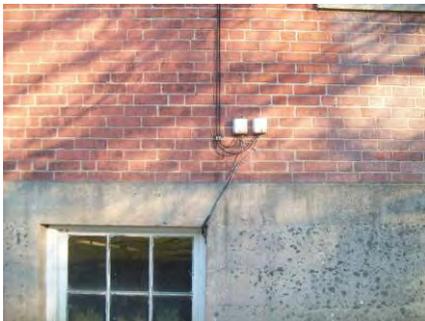
Telecommunications wiring runs overhead from a utility pole on Church Street and down the side of the building and through the framework of the basement window. No interior telecommunications wiring was observed within the building.

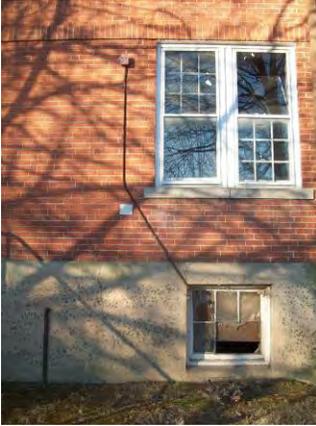
Only components remaining of the fire alarm system observed were a combination horn/strobe device and associated conduit located on the exterior of the building which was in poor condition and the disconnect switch located in the basement above the electrical panel.

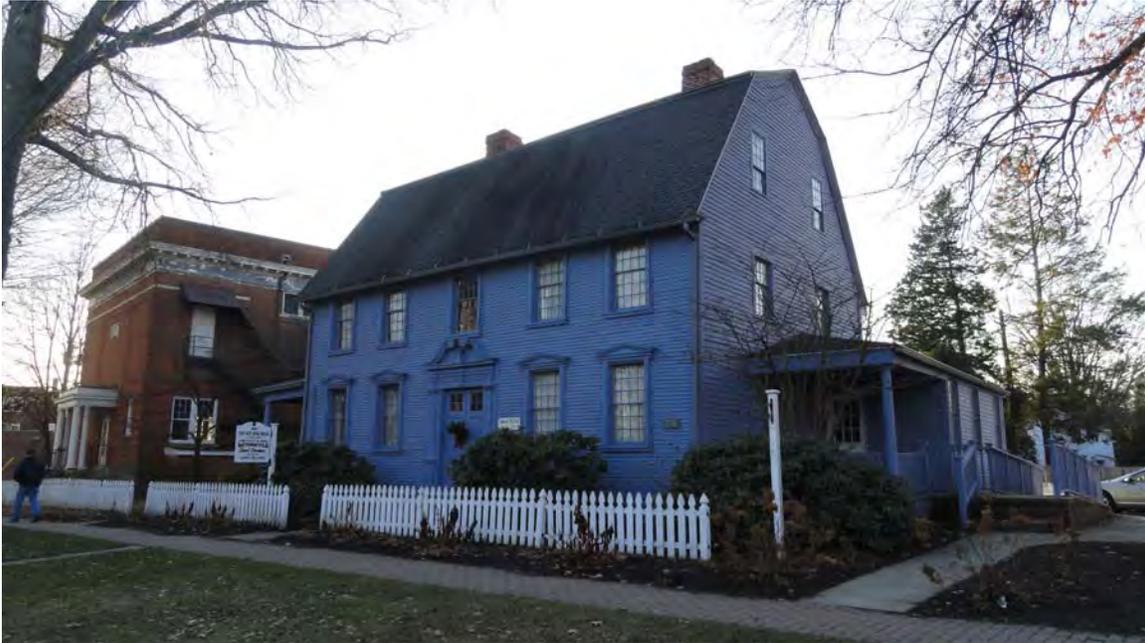
The Belden House, currently in use as a residence, is located between the Comstock Ferre property and the Masonic Temple. This building was originally constructed in the 1767 but the first floor framing appears to have been replaced at one point in its history. The first floor joists are 2x sawn timbers. The 2nd floor framing is not visible but exhibits slight sagging and sloping which is common to homes of this age. The gambrel roof framing, while probably undersized according to modern standards appears to be carrying all vertical loads without signs of extreme distress.

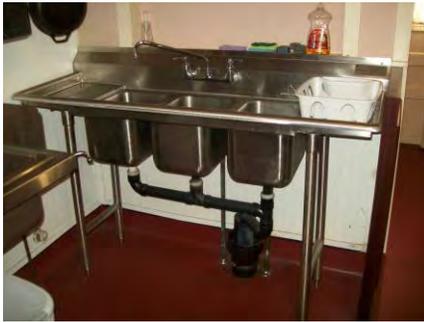
The kitchen has a stainless steel three (3) bay sink with single faucet and grease trap. The fixture appeared to be in good condition.

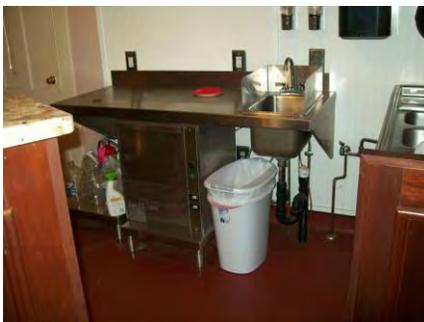
Adjacent to the three (3) bay sink a hand wash sink and dishwasher were observed. The fixtures appear to be in good condition.

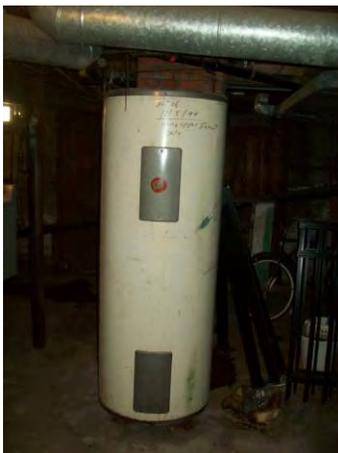
The basement has an abandoned electric hot water heater. Removal is required.

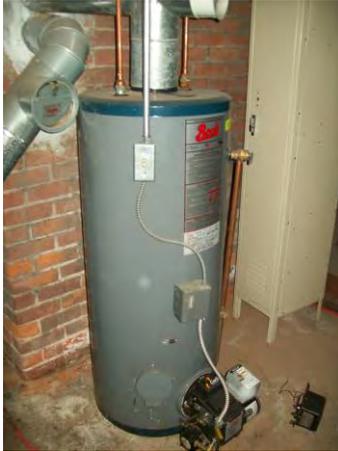
Domestic hot water is provided by a oil fired water heater, manufactured by the Bock Company and a oil fired burner by Carlin. The tank and burner appeared to in good condition.

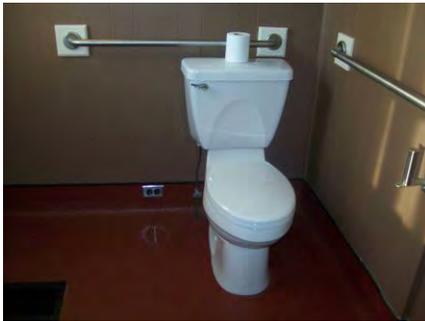
The first floor bathroom has a tank type water closet that appeared to be in good condition.

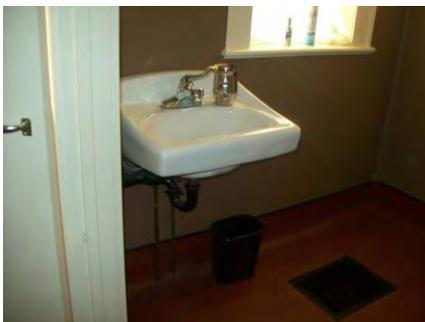
Adjacent to the water closet a newer wall mounted lavatory with a single lever faucet is installed and appeared to be in good condition.

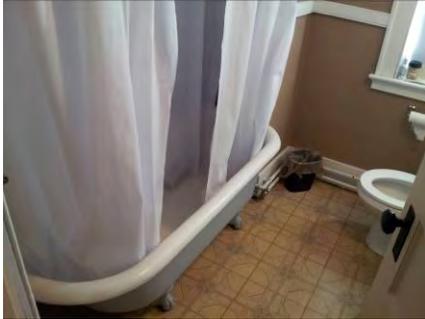
The second floor bathroom has a freestanding bath tub with an detachable shower head. Each fixture appears to be in good condition.

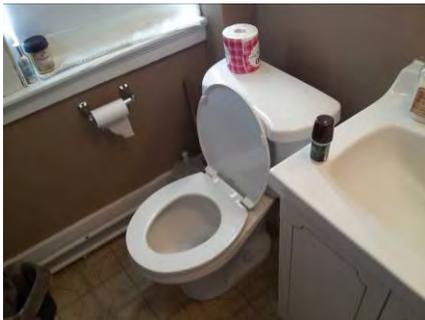
Adjacent to the bath tub a tank type water closet appeared to be in good condition.

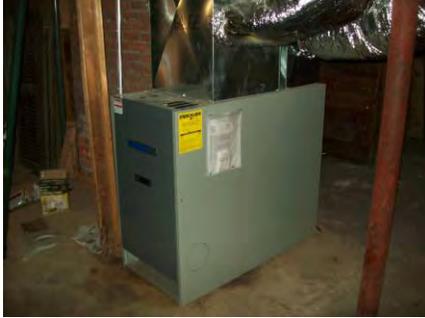
A new oil fired furnace manufactured by the American Standard Company provides heating for one side of the house. It is controlled by a wall mounted thermostat and appeared to be in good condition.

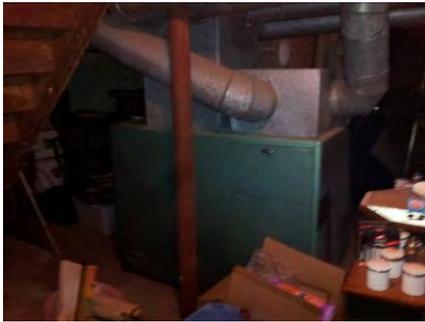
The basement has an additional oil fired furnace that serves the other living unit in the house. The unit appeared to be over twenty five (25) years old and in poor condition. Replacement is warranted due to age and condition.

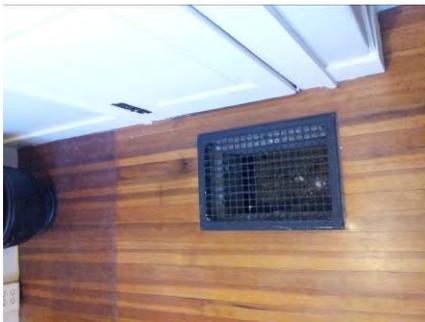
Floor and wall grilles were observed throughout the first and second floors. Each grille appeared to be in good condition

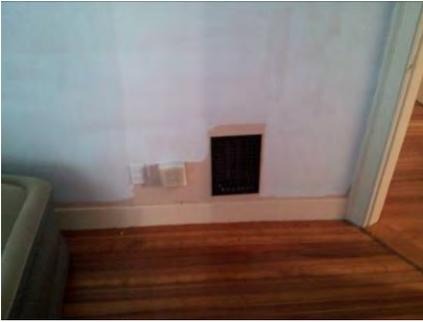
The majority of the rooms have sidewall grilles. All the grilles appear to be newer and in good condition.

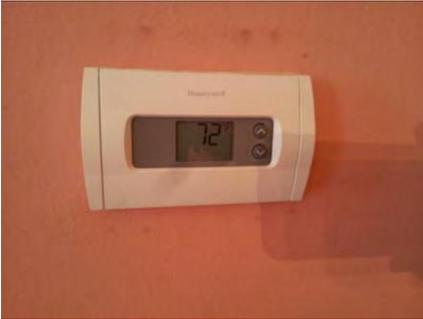
A wall mounted thermostat in the living room controls the oil fired furnace. The unit is manufactured by the Honeywell Company and is in good condition.

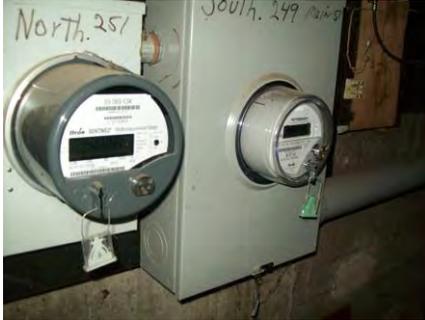
Electrical service for both address of the Belden House (#251 & #249) is routed underground from a utility pole on Main Street via a single PVC conduit to the basement of the building. The service rating for each address is 100 ampere at a 120/208V, 1-phase, 3-wire voltage configuration.

The electrical meter and panel for each respective address is also located in the basement. In addition, to the main panel for address #251, a 60 ampere sub-panel is located below it. This sub-panel appears to have been installed for the prior coffee shop located on the ground floor of #251.

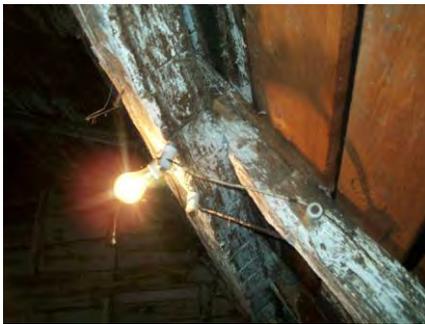
Branch circuit wiring for both addresses of the building consisted primarily of nonmetallic-sheathed cable (NMC). The few remaining circuits not NMC were routed in flexible metal conduit with the exception of the attic lighting circuit. Attic lighting is currently still utilizing Knob and Tube wiring.

EMT was installed in limited distances on HVAC equipment.

Surface mounted raceway (Wiremold) was observed in a few rooms.

Electrical junction box in basement was missing a cover plate.

Existing knob and tube wiring should be removed and replaced with new NMC cable. Appropriate cover plates should be provided for junction boxes missing them.

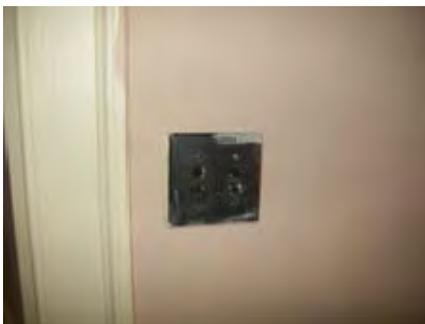
Switches primarily consisted of an antiquated push on push off type with the remainder being a standard toggle type. The switches controlled the lighting for the respective area.

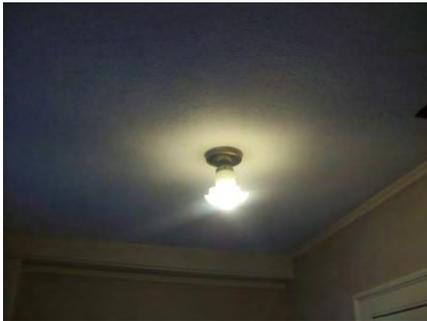
Lighting consisted of surface mounted light fixtures utilizing incandescent bulbs. Incandescent wall sconces were also observed.

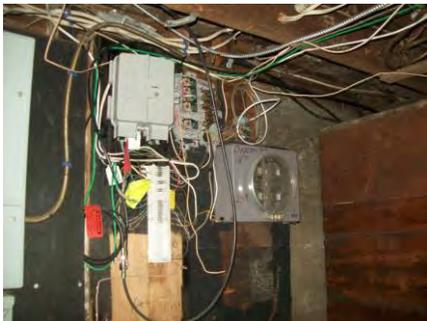
Telecommunications wiring is routed underground from utility pole on Main Street to SNI and punch down blocks located in basement.

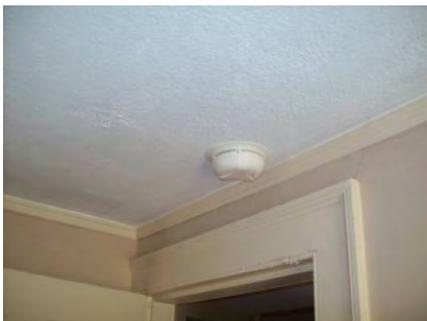
Fire alarm system consisted of smoke detectors located in limited areas of the building.

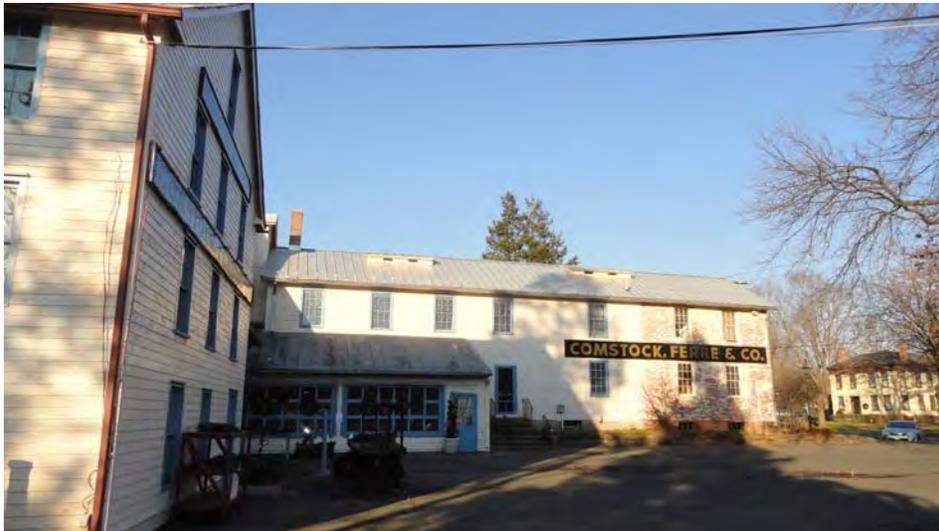
Much of the structure is concealed by paneling or plaster, however several portions of the floor and wall framing are visible. The floor framing consists of wide-board subfloor over widely spaced (>4') shallow joists. Signs of water intrusion and deterioration exist. It should be noted that a newer roof is on the building and this damage has most likely occurred in the past. There is a noticeable sloping and sag to the floors between supports. This is most likely due to undersized floor framing members and the possibility of failed mortise and tenon joints.

Regardless of the intended use of this portion of the building (either as retail, office, or assembly space) the floor and possibly the roof framing will require strengthening to conform to the current building code. As the depth of the existing floor system is fairly shallow (approx. 6”), the use of additional floor framing members are anticipated. New floor joists can be added (sistered) adjacent to the deteriorated joist. We recommend that the original joist be left in place to maintain the original nature of the structure. It is also likely that the mortise and tendon joints at the ends of the existing floor framing members have failed. The use of steel joist hangers would be required if this were the case. The condition of the remainder of the post-and-beam structure was not visible but it should be anticipated that a large portion will need to be strengthened to support the required loads.

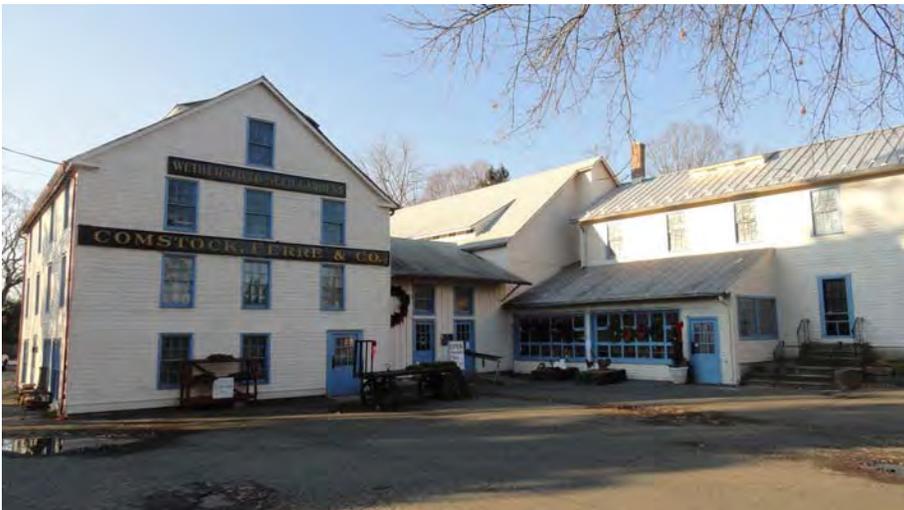
The western portion of Building A, which is currently in use as retail space on the first floor is a post-and-beam structure. A large portion of the second floor is currently unused. The second floor framing consists of 2 inch wide joists spaced at approximately 16” O.C. Many of the posts appear to be recycled from other structures as many have section loss due to past notching. The type of connections between beams and posts varies across the structure.

If the second floor were to be used as a retail or assembly space, it is expected that the floor joists would require little strengthening. It is anticipated that many of the post and beam connections are sub-standard and may require upgrading.

If an analysis of the floor framing reveals minor deficiencies, it may be possible to obtain a waiver from the building official for a lower floor load (CT Building Code 3407). The building code does allow for this type of waiver for historic structures. A limitation of maximum building occupancy or maximum storage load may be in order if this approach is taken.

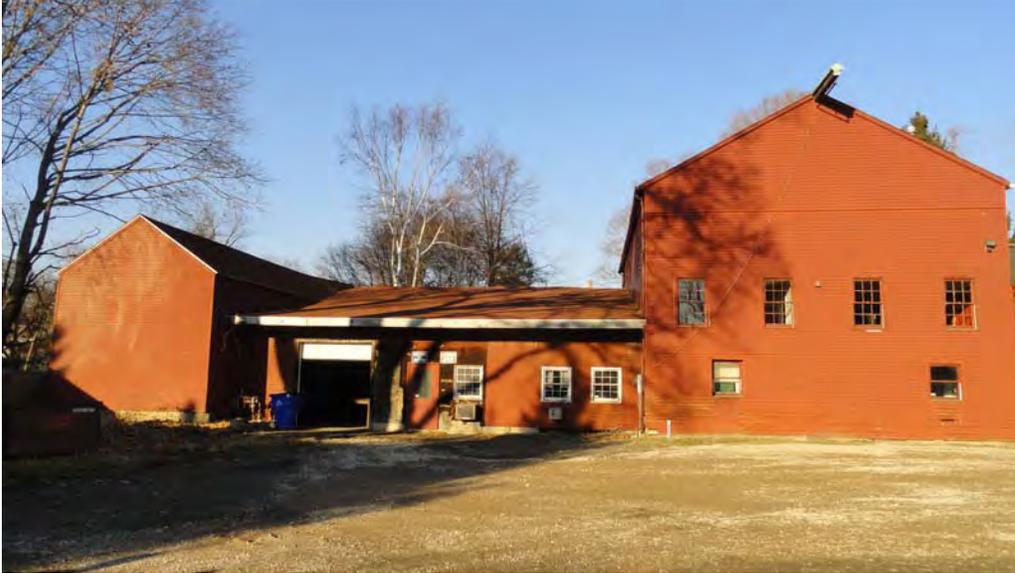
As stated previously in the past evaluations, the western portion of the barn is in the poorest condition. In many areas the roof is leaking and the existing timber framing is heavily deteriorated in places. While this portion of the barn may be rehabilitated, the cost may be prohibitively high.

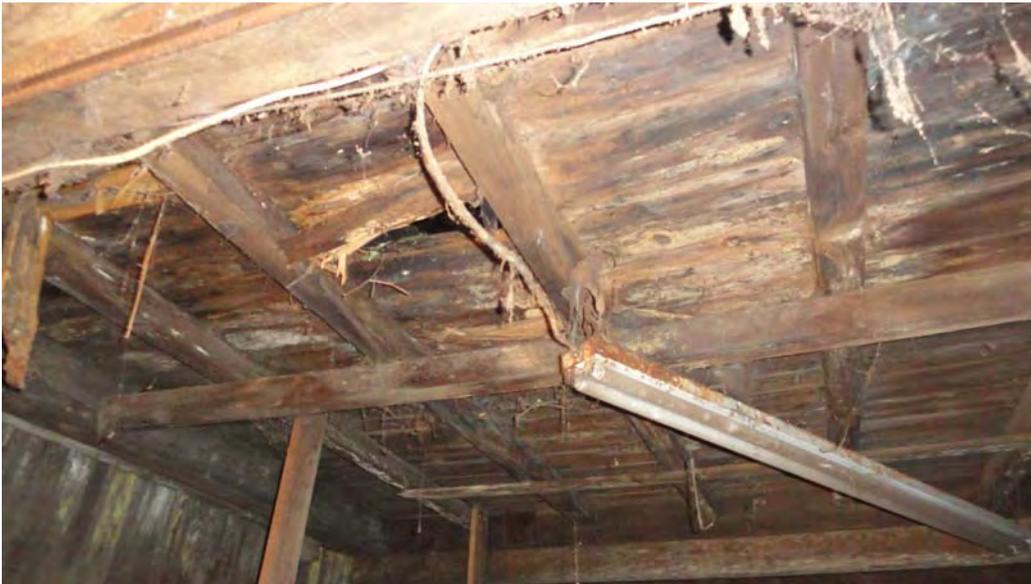
The center and eastern portions are currently finished and do not allow for a clear visual inspection of the framing. However, as no signs of distress are present (sagging, out of plumb walls, water intrusion, etc.) it is reasonable to conclude that the structure is structurally sufficient. If the upper floors of the center portion were to be used as retail or assembly it is likely that the floor framing would require strengthening to support these high proposed loads.

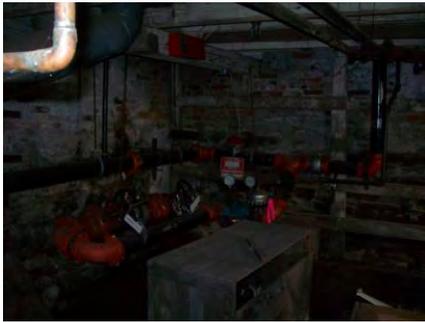
Located within the basement the fire service piping enters the building and is routed throughout the building. The wet system is comprised of upright sprinkler heads located on the first and second floors. The attic areas are not heated and are equipped with a dry system. The system valves and pipes appeared to have been recently serviced and in good condition.

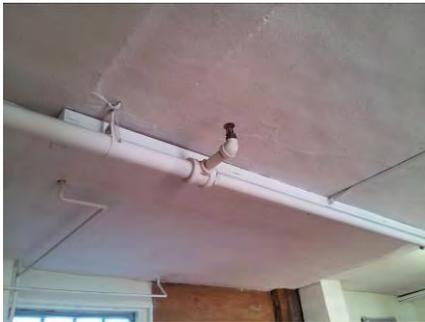
Typical upright sprinkler head observed on the first floor. In some areas the heads are equipped with baffles for protection. The heads appeared to be over twenty five (25) years old and in fair condition.

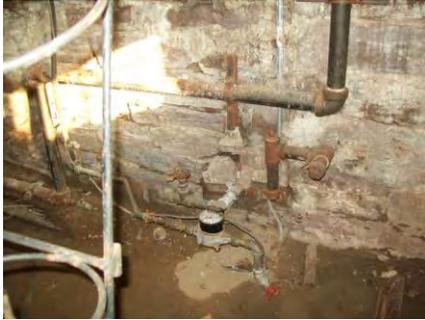
The building's water meter is located within the front of the basement. The piping and associated valves appeared to be in poor condition due to age. Replacement is warranted due to age and condition.

Replace piping where applicable.

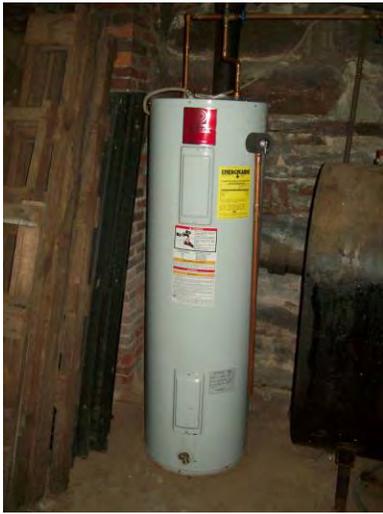
An electric domestic hot water heater is located in the basement and provides hot water to the plumbing fixtures. The unit is manufactured by the State Company, has a capacity of forty (40) gallons and appeared to be in good condition.

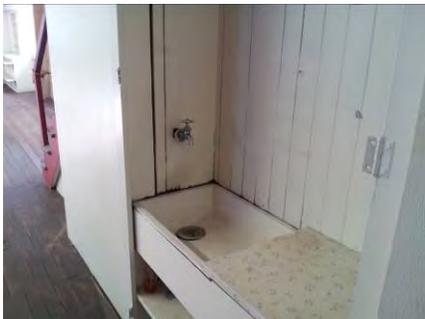
A single bowl sink was observed on the first floor. The sink and faucet appeared to be over twenty five (25) years old and in poor condition. Replacement is warranted due to age and condition.

Replace existing plumbing fixtures with low consumption models.

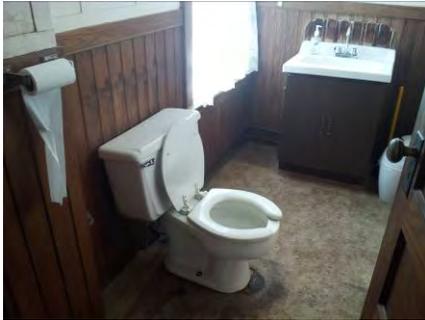
The building has one (1) bathroom located on the second floor. The bathroom has a tank type water closet and lavatory. Both fixtures appeared to average working condition.

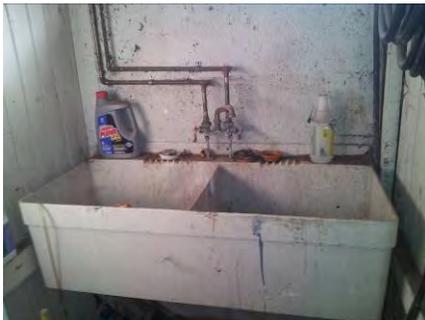
The basement has an fiberglass two (2) bay service sink with a single faucet. The fixture appears to be over twenty five (25) years old and in poor condition. Replacement is warranted due to age and condition.

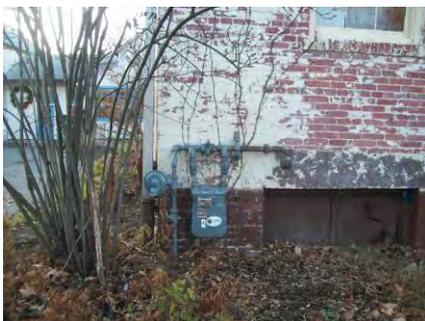
Natural gas for the building is provided by an exterior meter located in front of the building. The meter serves the gas fired heating equipment.

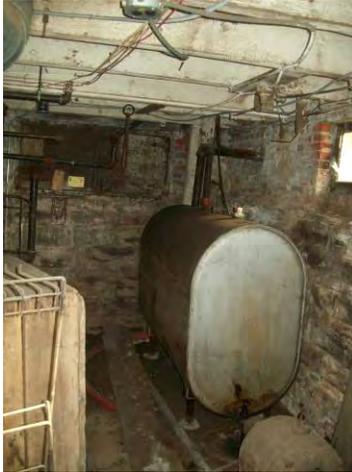
Two (2) fuel oil tanks are located within the basement. Each tank has a separate fill/vent and a capacity of two hundred and seventy five (275) gallons. The tanks appeared to be over twenty five (25) years old with exterior deterioration present. Removal is warranted for conversion to natural gas.

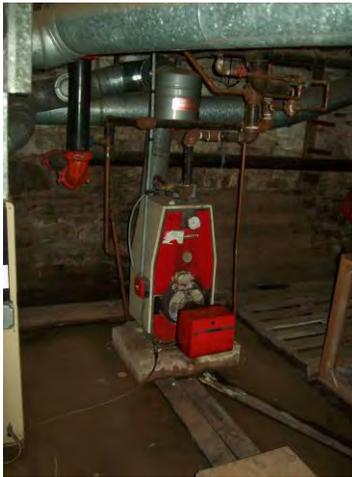
An oil fired hydronic boiler system is located within the basement. The boiler is manufactured by the Pennsotti Company and serves the cast iron radiation located on the second floor. The boiler system appears to be over twenty five (25) years old and in poor condition. Replacement is warranted due to age, efficiency, condition and the proposed system shall be gas fired.

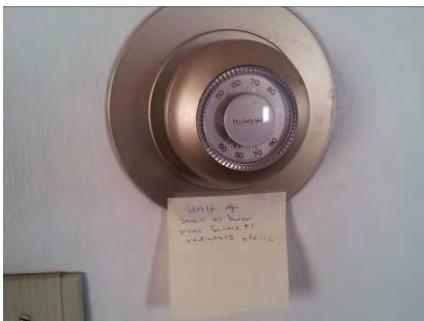
Wall mounted thermostats manufactured by the Honeywell Company provide control for the boiler and furnaces. The units are heating only, appear to be in fair condition and over twenty five (25) years old. Replacement is warranted due to age.

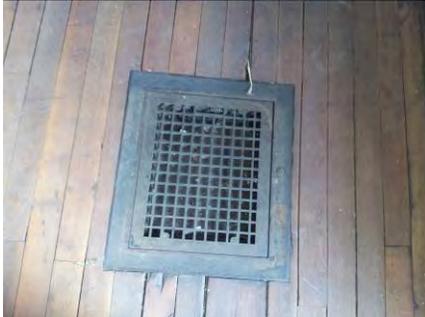
Cast iron floor air supply grilles are located on the first and second floors. The grilles appeared to be in fair condition with debris located within and minor deterioration present. Each grill should be cleaned and refinished.

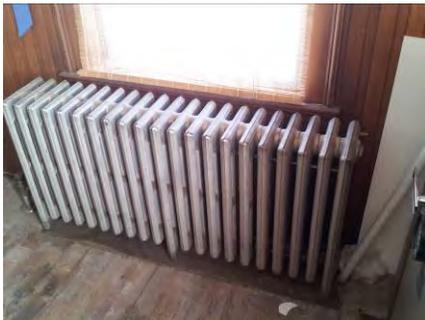
The second floor office area is heated by several hydronic cast iron radiation units. Each unit is manufactured by the Thatcher Company and is equipped with a shut off valve and air vent. The units appeared to be over fifty (50) years old and in fair condition.

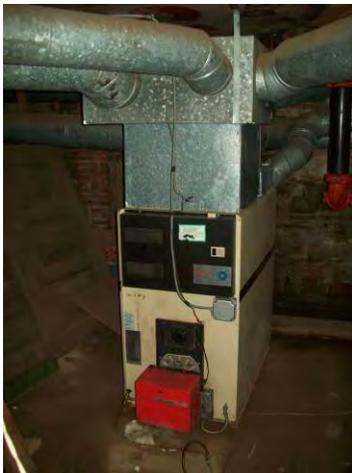
The first floor is heated by an oil fired furnace located within the basement. The unit is manufactured by the Machtron Company and serves the floor supply grilles on the first floor. The furnace appears to be over twenty five (25) years old and in poor condition. Replacement is warranted due to age, efficiency and condition. Proposed system shall be gas fired and all existing ductwork shall be cleaned.

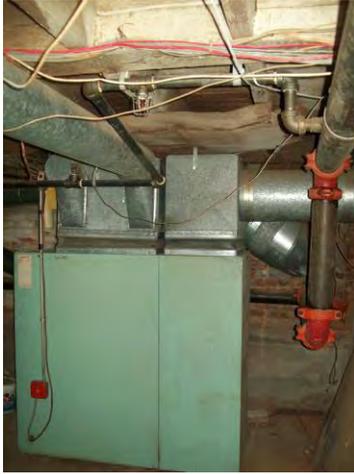
The second floor is heated by an oil fired furnace is located within a small area in the basement. The unit is manufactured by the Williamson Company and serves the floor supply grilles on the first floor. The furnace appears to be over twenty five (25) years old and in poor condition. Replacement is warranted due to age, efficiency and condition. Proposed system shall be gas fired and all the existing ductwork shall be cleaned.

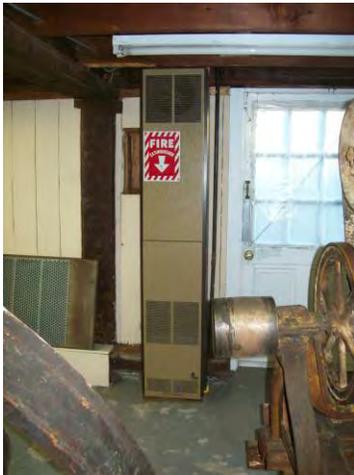
The first floor museum is heated by a single gas fired non-ducted furnace. A local thermostat provides control of the unit and the blower is constant volume. The unit appeared to be in good condition.

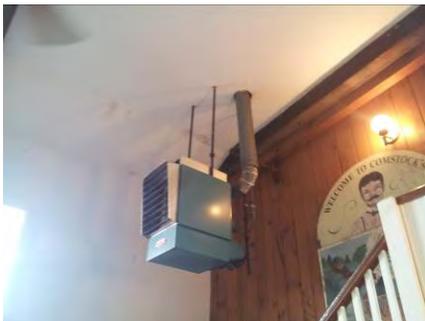
The building's front entry is heated by a ceiling mounted gas fired unit heater manufactured by the Bryant Company. A wall mounted thermostat manufactured by the White Rogers Company provides unit control. Each component appeared to be over twenty five (25) years old and in fair condition. Replacement is warranted due to age.

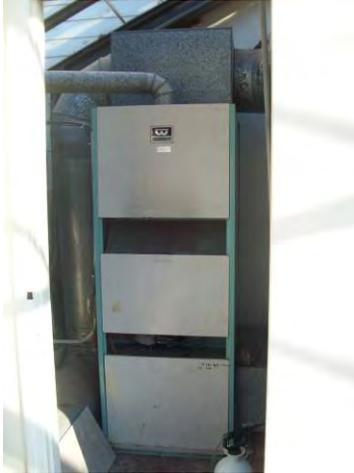
The Greenhouse is heated by a gas fired furnace manufactured by the Williamson Company. The furnace appears to be over twenty five (25) years old and in poor condition. Replacement is warranted due to age and condition. Existing ductwork should be cleaned prior to proposed unit installation.

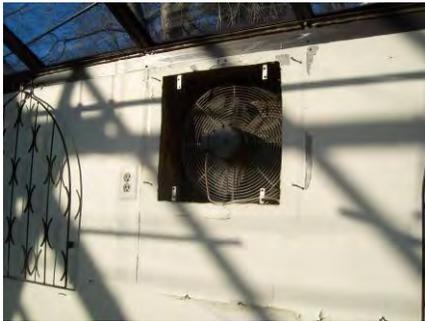
General ventilation for the Greenhouse is provided by a wall mounted propeller fan. The fan is controlled by a wall switch, appeared to be over twenty five (25) years old and in poor condition. Replacement is warranted due to age and condition.

Replace existing ventilation fan in Greenhouse.

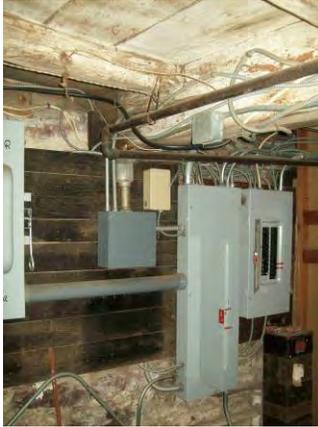
The service for the Comstock, Ferre & Company main building is routed underground from a street utility pole located on Main Street to the main electrical panel located in the basement of the building. The service is rated at 200 amperes at a 120/208V, 3-phase, 4-wire voltage configuration.

Dependent upon electrical load increase due to envisioned upgrades, electrical service for the building may have to be increased.

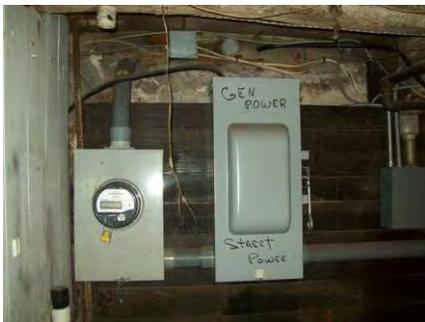
The electrical meter for the building is also located in the basement to the left of the main panel. A manual generator transfer switch was located adjacent to the meter. However, no generator is located on site and the generator connection point could not be located at the time of this site visit.

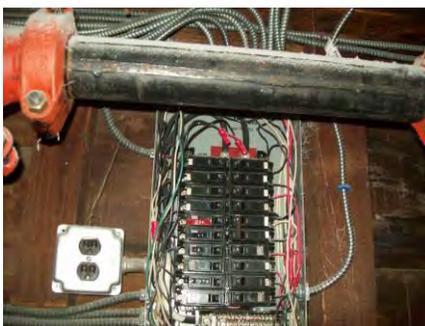
Five electrical panels were observed within the building. The main electrical panel and sub-panel were located in the basement. Two panels were observed on the second floor above the seed room below. An additional panel was located in the attic (pictured right). Attic panel was missing cover.

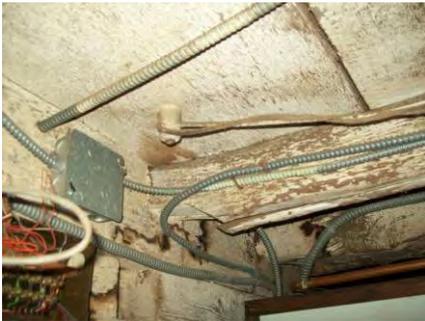
Branch circuit wiring is primarily run in flexible metal conduit in both concealed and exposed areas. EMT was also utilized for some branch circuits where installation required surface mounting of conduits. Wiremold surface raceway was also installed in some areas which required surface mounting. In addition, nonmetallic-sheathed cable (NMC) was also observed in a couple of instances in the attics and in the basement.

All remnants of the knob and tube wiring still in place should be removed. All NMC circuits should be replaced with wire installed in metal clad (MC) conduit.

Replacement of NMC circuits with Metal Clad (MC) cable.

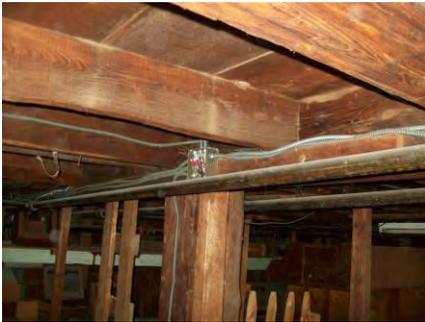
A number of electrical outlet and junction boxes were missing covers.

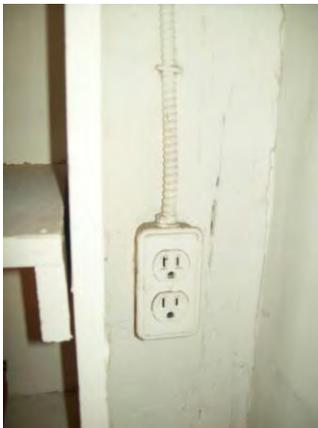
The vast majority of receptacles within the building are NEMA 5 duplex receptacles. They are primarily surface mounted on the walls as well as the ceiling in some instances. A large number of them have been painted over. A few were observed to be NEMA 1 and do not contain a blade for a ground prong.

Switches were primarily single pole and controlled the lighting within their respective areas. A few switches were also painted over.

All receptacles and switches should be removed and replaced and GFCI duplex receptacles installed in all locations required by the National Electrical Code (NEC).

Replace existing receptacles, switches and add additional where warranted/required by code.

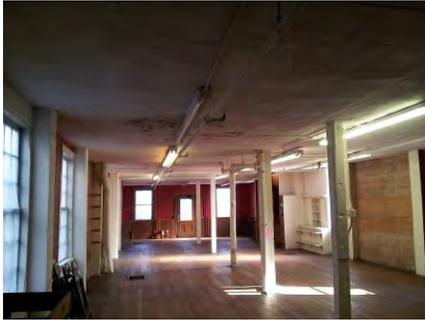
Lighting within the building consisted primarily of eight foot two lamp surface mounted fluorescent fixtures utilizing T-12 lamps. Porcelain sockets with incandescent bulbs provided lighting in the attic spaces. Lighting within the seed area was provided by festoon lighting. Also observed were a few incandescent wall sconces, four foot fluorescent fixtures with T-12 lamps and a ceiling fan. Lighting in the green house was provided by incandescent fixtures mounted at the peak with floodlight bulbs installed. Also observed were surface mounted two lamp fluorescent fixtures.

Existing light fixtures are inefficient, antiquated and in overall poor condition. All lighting should be removed and replaced with new energy efficient fixtures.

Replace existing light fixtures with energy efficient fixtures.

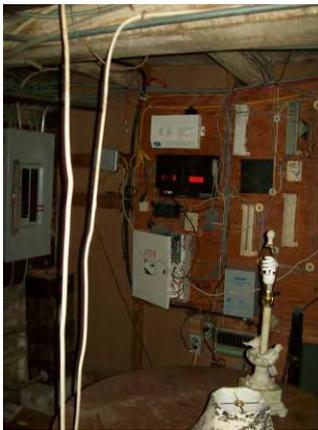
Telecommunications wiring is routed underground from a utility pole on Main Street. The demarcation point is located in the basement adjacent to the main electrical panel on a plywood backboard. The backboard contains punch down blocks and a security control panel which is no longer in use.
